ÇATALHÖYÜK 2009 ARCHIVE REPORT

Çatalhöyük Research Project

*Archive Report 2009 compiled by Shahina Farid
Photos by Jason Quinlan (unless specified)
Plans by Cordelia Hall (unless specified)*

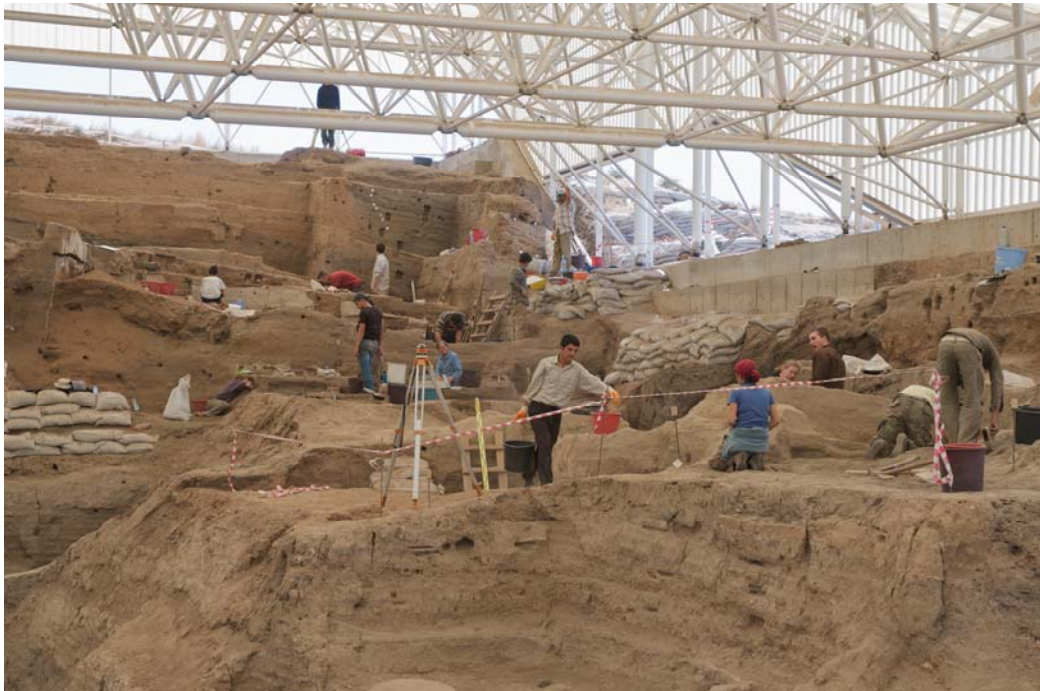
Figure 1: General view of the excavations in the South Area at Çatalhöyük. Photo Jason Quinlan.

The aims of the excavation this year were to uncover some well-preserved burned buildings in the South Area of the site (Figure 1). We have been concentrating our work in this area in order to understand the development of the site through time. There is some evidence that the whole of the site underwent major change in Level VI, half way through the 1400 years of occupation. There is much burning of buildings in Level VI. There is also the appearance of public open areas, with public ovens and much digging of pits to obtain clay, and then re-use of the pits for rubbish. The occupation after Level VI is more dispersed, and the north part of the site starts to be evacuated. Many of the distinctive characteristics of Çatalhöyük such as the bull horns start to die out after Level VI. There are of course changes that lead up to Level VI, but the fires at the end of this phase seem to be associated with an important shift in the pattern of occupation.

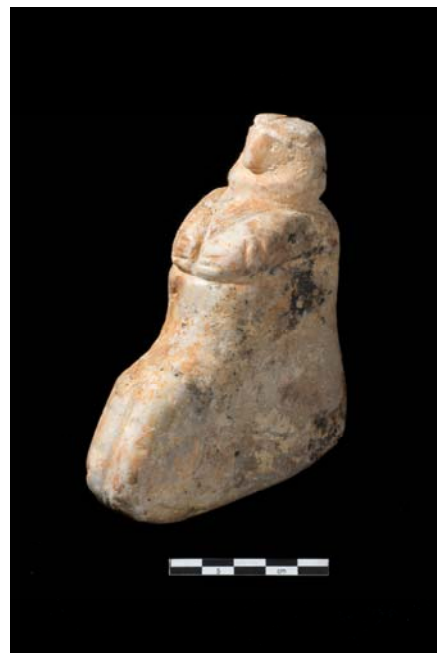
Figure 2: Figurine, probably of a bearded man, from the burned fill of Building 79. Photo Jason Quinlan.

Some of the buildings burned in Level VI are very well preserved. The walls of some of these buildings have been found standing over 3m high. In one of the burned buildings, Building 79, we found a beautiful stone figurine of a bearded man (Figure 2) as well as another stone figurine.

This unit was sealed by burnt room fill (18523), which consisted of extensive brick and plaster collapse along west side of building. Some of the moulded plaster in this deposit may have originated at the junction of walls and ceiling of the building. Pieces of wall collapse were at least four bricks high, and the wall of Building 79 must have originally been at least four courses taller. Many of the bricks in this deposit were large in size and matched the ones in the surviving northern and western walls. This deposit contained a stone seated male figurine (18523.x1 (see Figure 2), grinding stone (18523.x2), and an obsidian tool (18523.x3). These

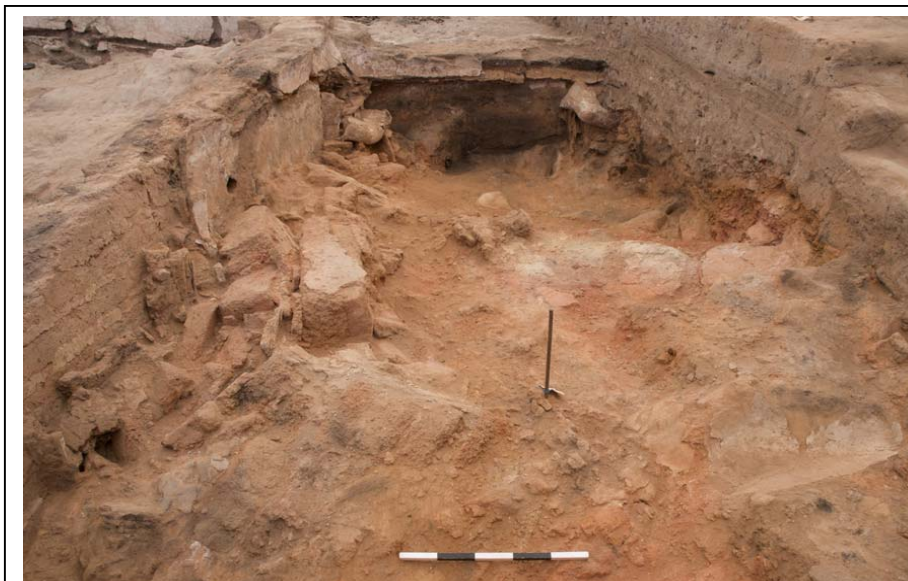
Figure 3: View of the western part of Building 79, with some room fill visible to the right. One of the pillow-shaped pillar capitals can be seen to the right. Photo Jason Quinlan.

The first clue came from Building 79. This was found filled with burned brick and plaster (Figure 3). In the middle of the main room there was a collapsed wall that seemed to be attached to a floor – but not the floor of the main room. The plaster on the inside of the collapsed wall and floor was fairly coarse and much thicker than on the floor and walls of the room itself. The collapsed wall and floor were too massive to have moved far – the only possible explanation was that they had fallen down from an upper storey.

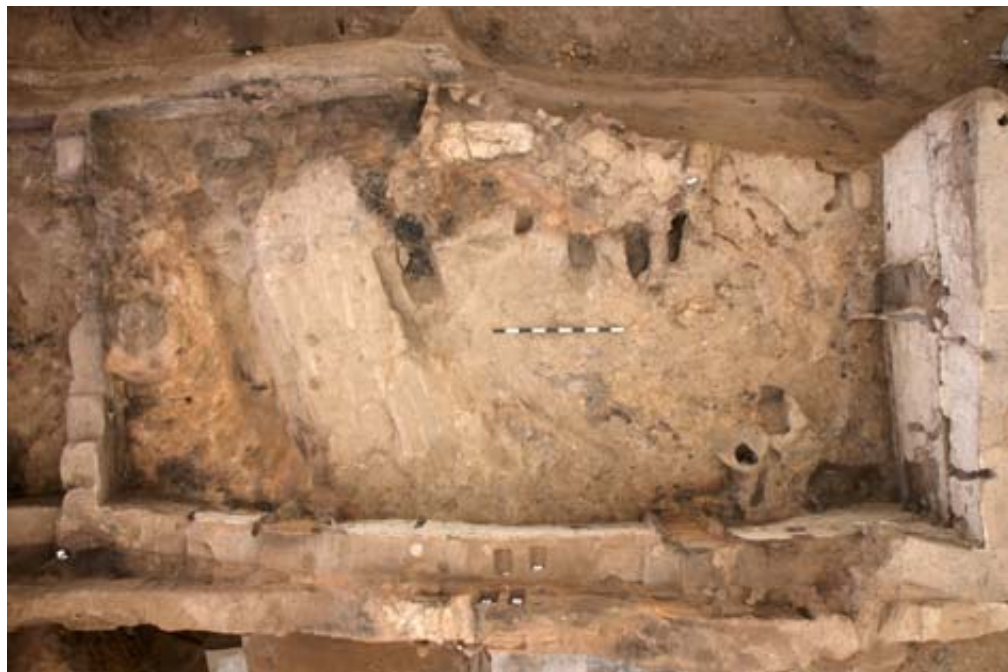
Figure 4: The north (right) and east (left) walls in Building 80, with fill still remaining in the lower part of the room. A deep slot is visible on the north wall. Photo Jason Quinlan.

Collaborating evidence came from burned Building 80 (Figure 4). Here we found much too much collapsed walling to be explained by the simple architecture that we had always presumed. Most buildings at Çatalhöyük were not burned on abandonment. Rather, they were carefully cleaned and dismantled so that no trace of any upper storey, if it had existed, survived. We had begun to suspect that upper storeys might exist because when we built a replica of a typical Çatalhöyük house it was clear that there was no need for the timber posts that are always found in the main rooms of buildings. A single storey building made of mudbrick in this area stands up perfectly well without huge wooden posts. It seemed, as Marion Cutting suggested, that the posts might hold up an upper storey, but we had never found any evidence of this in the unburned buildings. But burned buildings preserve the traces of the upper parts of buildings, the post mouldings, the corners, the bricks. And here in Building 80 it was clear that there were many different sizes of bricks, and too many of them for a simple one-story building. Also in Building 80 we found fallen pieces of very large wooden beams with plastered floors attached – and these plastered floors were clearly internal, not external, floors.

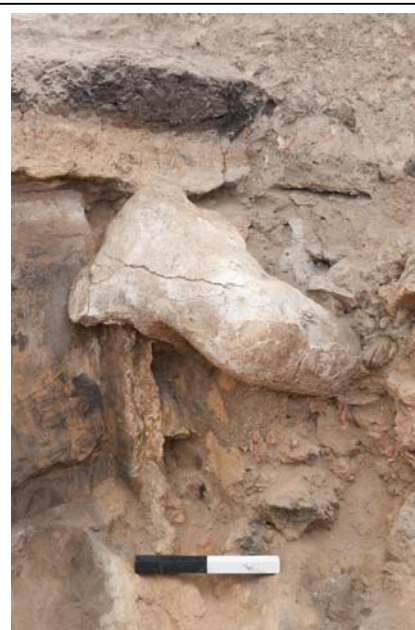
Figure 5: Close-up of the pillow-shaped capital in Building 79. Photo Jason Quinlan

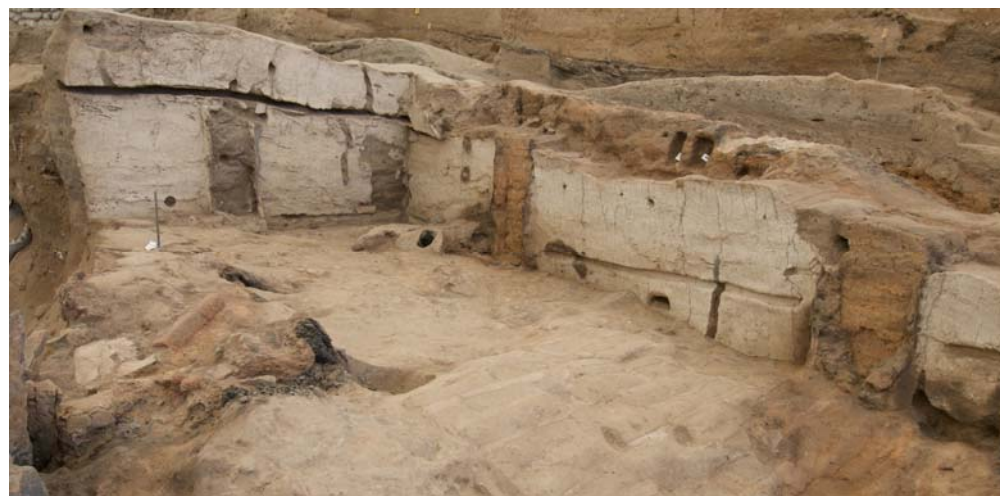
Figure 16: Plastered north and east walls with post scars, decorative horizontal grooves and the possible beam slot in the north wall. Looking NE. Photo Jason Quinlan

This room is delineated by wall F.2533 at the north, F.5014 at the east, F.5036 at the west with walls F.5037 and F.5038 forming the southern side, these lying either side of a crawl-hole into the southern room Space 373. The northern wall of the building, F.2533, is particularly well preserved, standing over 2.1m in height consisting of at least 18 courses of mudbrick. This contrasts with the less well preserved walls towards the south of the building and also with the western wall whose upper extent appears to have been lost to erosion, post Mellaart's excavation. All the walls of the northern room show multiple layers of white plaster, with traces of red pigment apparent within some plaster layers on the eastern wall. Some internal features within the building have also revealed themselves. Lying against the southern wall of the northern room there is what appears to be the top of an oven, F.5041. Pairs of posts in the form of post scars line the eastern and western walls, while the top of another pillar lies in the centre of the northern wall. Other exposed features within the building are a series of decorative horizontal grooves running horizontally between the post settings on the northern and eastern walls of the northern room. There is also a small, deep-set oval niche within the eastern wall (Figure 16). The relatively well preserved northern wall also preserves what may be the remnants of a horizontal beam-slot (containing charred timber remnant (18502)), running above the central post. While not as yet wholly clear it is likely that this slot held a timber or timbers that supported of a second floor. Perhaps indicative of this is the fact that the plaster on the walls directly above and below the slot lip out, possibly indicating the presence of a floor/roof.

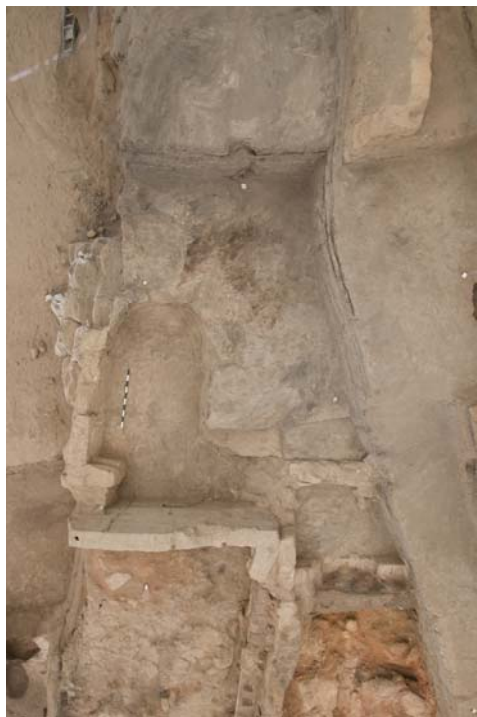
Figure 17a: Overview of B.86. (N to top). Photo Jason Quinlan.

This building abutted both buildings 79 and B.80 at the north (Figure 13) and appeared to consist of two rooms or spaces Space 375 at the north and Space 376 at the south. The eastern limits of the building appear to lie beyond our present eastern LOE (Figure 17 & 17a).

The northern wall, F.5024, demarcated the present northern edge of excavation. Part of the upper edge of the western wall, F.5025, was truncated but the SW extent of the wall was revealed, this abutting / adjoining southern return wall F.5026. Part of this southern wall would appear to have collapsed as indicated part of leaning section of the wall seen at the E edge of excavation. A small room may also exist to the south of this wall as suggested by wall returns F.5029 and F.5030, these forming Space 376. The exposed wall lengths suggest that the northern room is plastered, although, this appears to be in one or two renders only with no suggestion as yet of multiple layers as seen in Buildings 79 and B.80 to the south. From the exposed Mellaart section this building would appear to have been partially backfilled with compact mudbrick-like material (18537), this only partially excavated this year in order to delineate the south wall of the building. The abandoned building as with buildings B.79 and B.80 then becomes part of an open area Space 344.

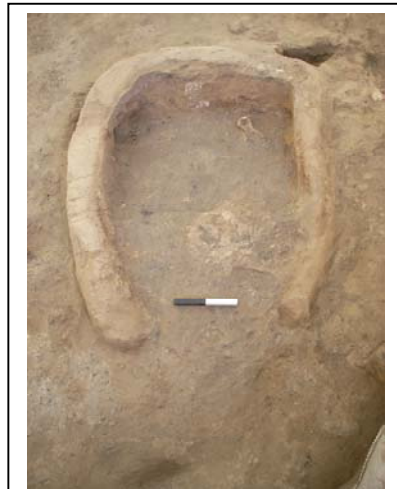
Figure 18: Oven F.5018 during excavation of (17371). Photo James Taylor.

Sealing the later oven floor on the southeastern side of the structure was a small dump of yellow clay-silt, (17393), which may have represented the first signs of degradation of the superstructure (Figure 18). This was immediately sealed by a thick silty-ash, (17371), which itself included some collapsed plaster, perhaps from the upper part of the superstructure. This was finally filled with an 80mm thick band of brick rich mid-yellowish brown clay silt fill, (17387) which marked the collapse of the oven superstructure.

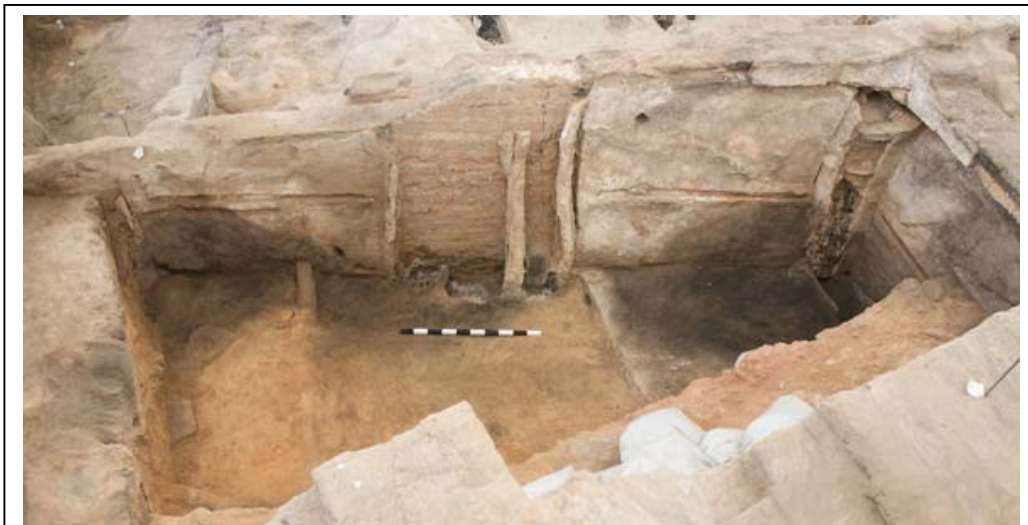
Figure 22: View of B.79 facing W. Photo Jason Quinlan.

slot in the northern wall of the building and evidence of large cross beams suggest the building may have had a wooden second story. The building was filled by burnt collapse that contained two seated male marble figurines, large quern stones, and number of smaller ground stone artefacts. After Building 79 was destroyed by fire it was abandoned. Building 80, and possibly Building 76 both lying to the west, appear to have been destroyed at the same time; after the fire this area of the site then became an external activity area, Space 344.

A southern platform, F.5034, extended beyond the limit of excavation to the east and south (see Figures 21 & 22). The northwest edge of the platform was demarked by a small kerb. In the southeast corner of the excavation area the edge of a sub-circular feature, F.5035, probably represents an oven. Set into the platform, to the west of the oven two grinding stones appear to have been in situ, and may have been associated with food preparation activities. The surface of this platform, the central floor, and the northern platform were heavily burnt and discoloured.

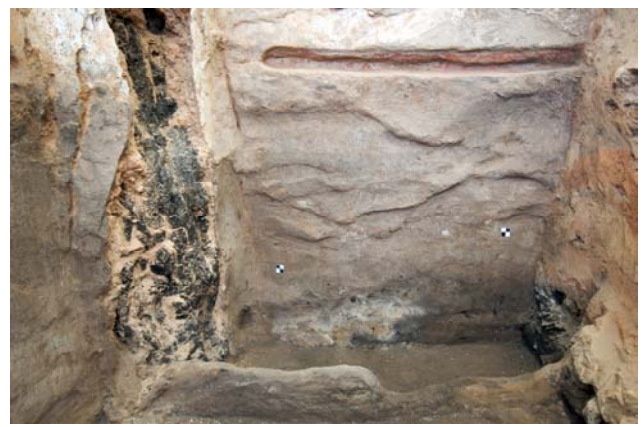
Figure 23: Detail of plaster on N wall with red horizontal groove and carbonized post to left (F.5019). Photo Jason Quinlan.

Building 79 was defined by a northern wall, F.5012, and a western wall F.5013. Both walls were constructed of mudbricks measuring 0.30m wide, 0.08m tall and over 1.00m in length. Both walls extend beyond the limit of excavation, and so their true dimensions are unknown. The western wall contained two decorative horizontal grooves, F.5023 and F.5027. The northern wall contained an identical groove F.5042 (Figure 23). These niches measured approximately 1.45m long and up to 0.10m high. They were recessed into the walls 40mm

and were between 0.70 and 0.80m from the floor. The grooves were plastered with white marl, however below this latest plastering event all three niches were painted red. These features appeared to be purely decorative, with no obvious structural function. In addition the northern wall contained a number of areas of moulded plaster, which formed wavy ridges on the lower part of the wall.

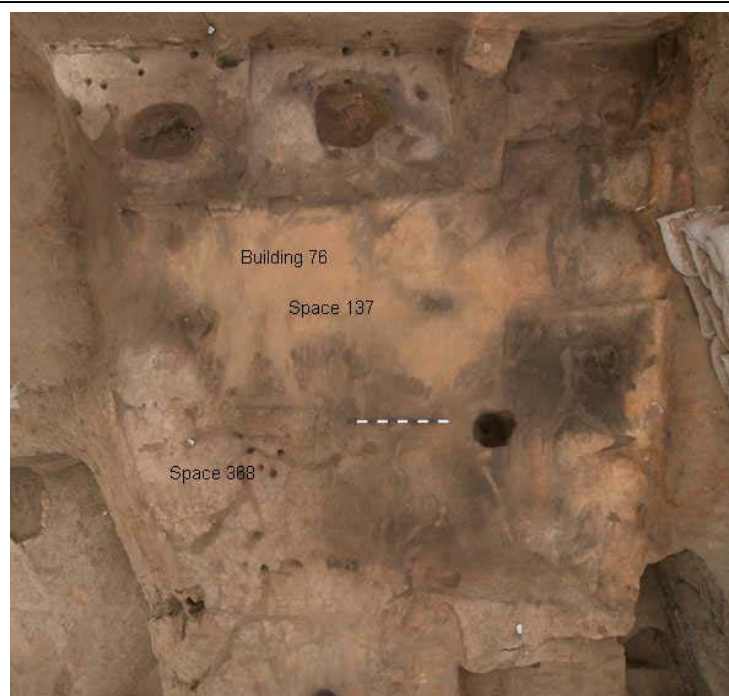
Figure 27: Overview of Building 76 showing extent of the fire. East to top. Photo Jason Quinlan

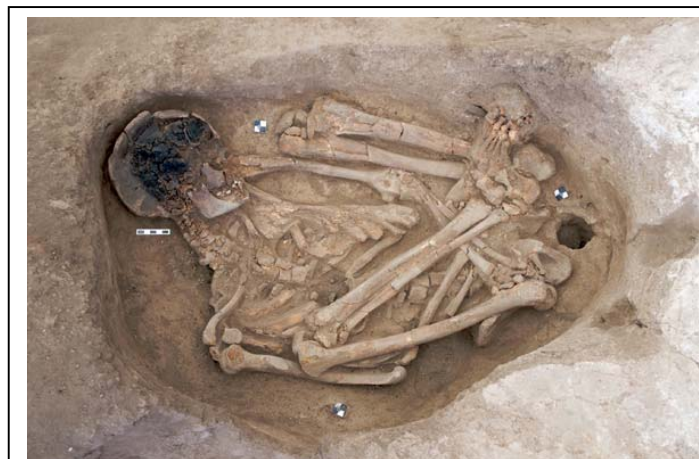
Figure 28: Adult skeleton (18496) F.3421 in a crouched position. The radiating heat from the fire had penetrated through the grave fill and discoloured the bones to black/brown. Photo Jason Quinlan.

Cutting the above sequence was the first burial F.3421. This single adult skeleton (18496) was buried in the northern half of the platform in grave cut (18497) in a crouched position on its left side facing northeast (Figure 28). The radiating heat from the fire had penetrated

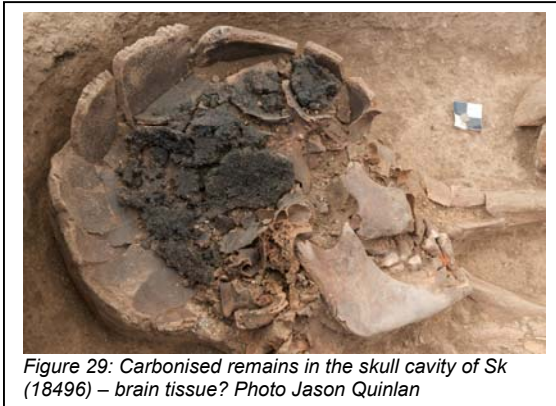
Figure 29: Carbonised remains in the skull cavity of Sk (18496) – brain tissue? Photo Jason Quinlan

through the grave fill (18489/18491) and discoloured the bones to black/brown. Of particular note is the presence of burnt organics within the cranial vault (Figure 29 - brain tissue?) this was found in all the burials in B.76. A single flint tool was found at the feet (18489.x1). The burial was sealed with a succession of floors and make up layers removed as a single unit (18486) up to 4cm thick, all heat effected and varied in colour from light grey to dark brown. This surface was cut by (18455) the second and final burial in the NE platform. The burial F.3418 consisting of

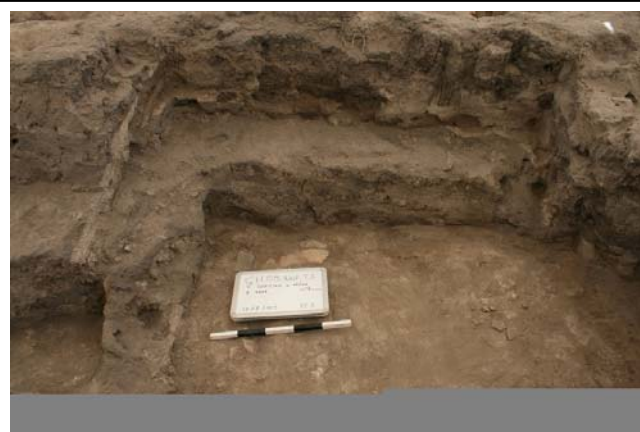
Figure 36: Bench F. 3303 in Space 342. Photo Peter Biehl.

In Space 342, roomfill was removed in three units ((16896) dug in 2008 and (18309), (18311) and (18328) dug this year). Shard fittings between these spits and the interpretation of the S section corroborate the view that the changes in soil consistency we encountered between these units did not represent lenses of infill. Its deposition must have been rather rapid, as it is indicated by the low degree of fragmentation of the potshards found and by the presence of unusually well-preserved animal bones with the articulated unfused epi- and diaphyses of juvenile bones (see this report, cf. I. Franz on pottery and Fauna West Mound Tr 5). The fill covered a feature (F.3303), which was constructed from grey mudbrick and white mortar similar to the space's walls (F.5051 and F.2424) (Figure 36). As the feature resembles the benches found by David French in Can Hasan I 2B (French 1998) we currently interpret the internal installation in Space 342 also as a bench. As the plaster on wall F.5051 continues behind F.3303, the bench seems to be a later addition to the space.

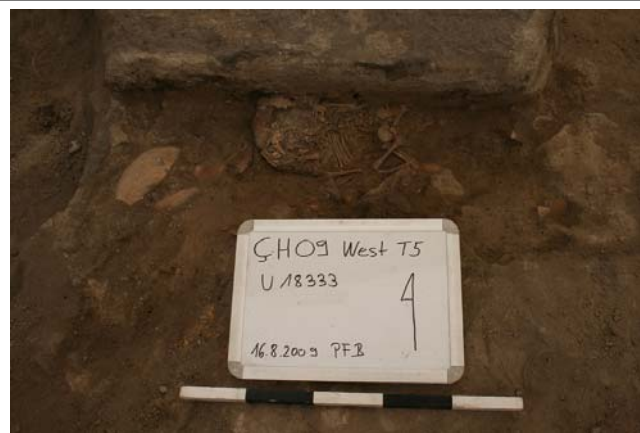
Figure 37: Neonate skeleton (18333) in front of buttress F.5061 in Space 342. Photo Peter Biehl.

Byrnes) was placed with its head in the W in a contracted ventral position (Figure 37). Its right arm was closely abutting buttress F.5061 and no traces of a grave cut or basket etc. could be detected. The situation closely resembles skeleton (16835) that was uncovered last year placed on top of the bench F.3303. The deposition of neonates seems to be part of the rapid infill episodes, thus similar to the nature of the infill encountered in Hacilar I, which was, according to Mellart's interpretation "filled with pottery, objects and the burnt skeletons of slain victims, especially children" (Mellaart 1959, 54). An ashy spot (18345) on this surface was surrounded by several potstands 18328.X17, 18328.X19, 18328.X20 and 18341.X19) (Figure

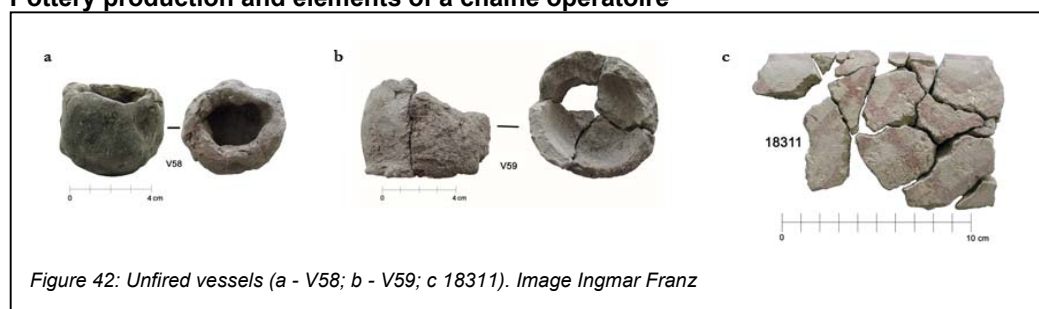
Figure 42: Unfired vessels (a - V58; b - V59; c 18311). Image Ingmar Franz

Since last year's discoveries (Franz 2008) it was clear that more finds and evidence for possible pottery production processes could be expected from this year's excavation. Indeed, many unfired pottery fragments were found and often belong to clusters or even to whole vessel parts (e.g. (18311), (18313), (18323) (Figure 42). The painted rim part from (18311) in Space 342 is the most impressive example for an unfired pottery cluster from the West Mound so far (Figure 42c). Altogether they prove that the painted "EC I/II-Ware" was definitely produced on site, which represents an extraordinarily rare archaeological situation. Since last year, 21 units revealed pieces of unfired pottery. Alone in Space 310 seven units contained unfired pottery, four Units in Space 342, three in Space 345 and two in Space 340, Sp.341 and Sp.343 each.

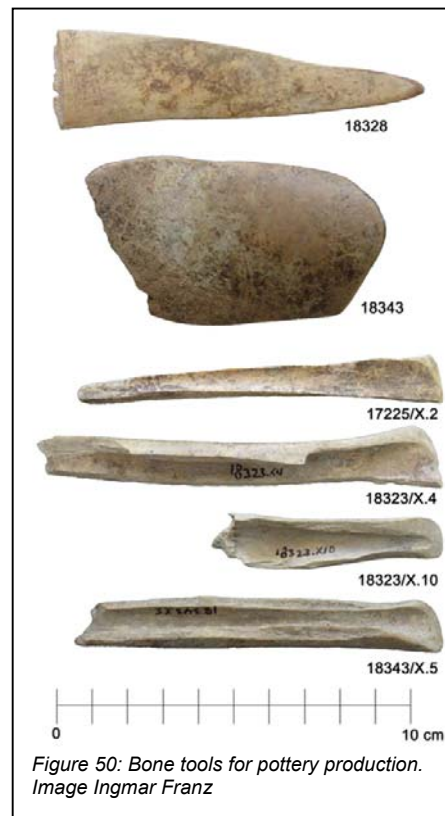
Figure 50: Bone tools for pottery production. Image Ingmar Franz

It is interesting to note that a similar basalt grinding platter fragment with pigment from Space 310 (Figure 51) was found in Trench 8 (find 15588.X7). Three types of possible potter's bone tools were identified (Figure 50). They all show traces of use and a have specific tool shape. They could have been used as a scraper or paddle ((18328) & (18343)), or for burnishing (17225.X2, 18323.X4, 18323.X10 & 18343.X5). Also the so-called shard tools can be included in this production sequence and have either geometric shapes like rectangles or hexagons (Franz 2007, fig 88) or curved triangles (Fig 18, (18303)). A possible use could have been as stencils for applying the painted decoration on the pottery. Others could have been used as scrapers or paddles (Franz 2007, fig. 88, (18316)) or as burnishers (16896), (18328), 18343).

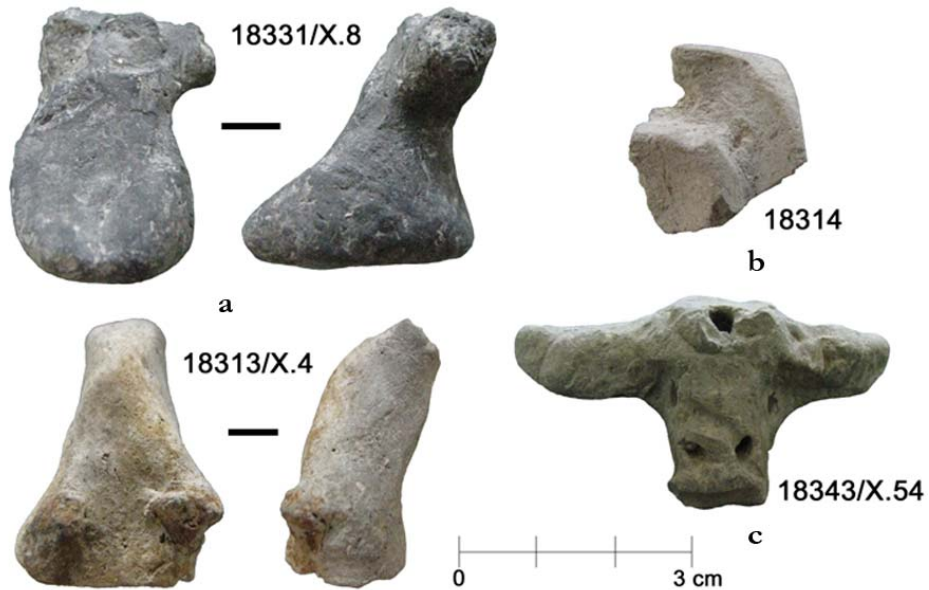
Figure 53: a – two anthropomorphic clay figurines; b – fragment of a stamp seal; c – miniature clay 'bucranium'. Image Ingmar Franz

Here are some special pottery finds from the 2009 field season: a large incised shard with an unusual "palm-tree like" decoration (Space 340, (18313)) (Fig 52a). A painted base shard of a bowl with a possible human representation (hand and arm) (Space 342, (18328)) (Fig52). An earthen spoon (Space 342, (16896) & (18341)). Two anthropomorphic figurines (Space 340/341 (18313) and Space 345 (18331) (Fig 53a). A small fragment of a stamp seal (Space 343, (18314)) (Fig 53b) and a very appealing miniature cattle head of clay figurine which was perforated (Space 310, (18343) (Fig 53c).

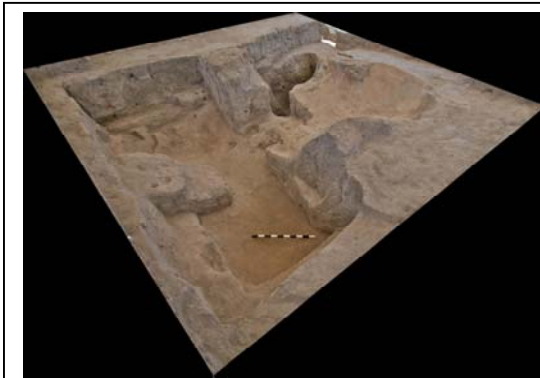
Figure 54: Building 78. Looking South-West.
Image Tr.8 Team

Second, it is now clear after three excavation seasons that Building 78 is quadrangular in plan with two storeys and 3 internal buttresses (Figures 54 & 55). Building 78 is a relatively large sized special building of c. 8m across. Floors of the first and the second storey as well as plastered walls of the second storey were painted in red. The red paint was kindly analysed by T. Carter with X-Ray Fluorescence, and was found to be ochre.

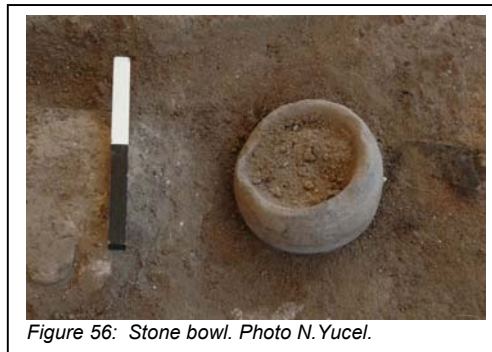
Figure 56: Stone bowl. Photo N.Yucl.

First, the discovery of the architectural remains in the southern part of the trench provides the first evidence of the ECII occupation. Until now no architectural remains of EC II have been found on Çatalhöyük West. ECII materials had been only come from some pits in the southwestern part of the mound. In Trench 8, EC II is represented by partial architectural remains and heavily disturbed fill due to present-day surface activities. A domed oval oven F.2966 with its mouth to the south was found. It was a disturbed oven measuring 1.4 x 0.8m with only one oven floor. A partition wall (?) of at least 5 single mud-bricks lies north of the oven. The mud bricks measure 0.7-0.8 x 0.3 m in size and 0.15 m in thick. To the southern side of the oven was a deposit containing lots of burnt construction materials with frequent EC II pottery and animal bones. Noteworthy objects from this deposit are two vessels with painted human figures, a stone vessel with a carved crayfish figure and a spondylus bracelet. A stone bowl was also found on the west side of the oven (Figure 56).

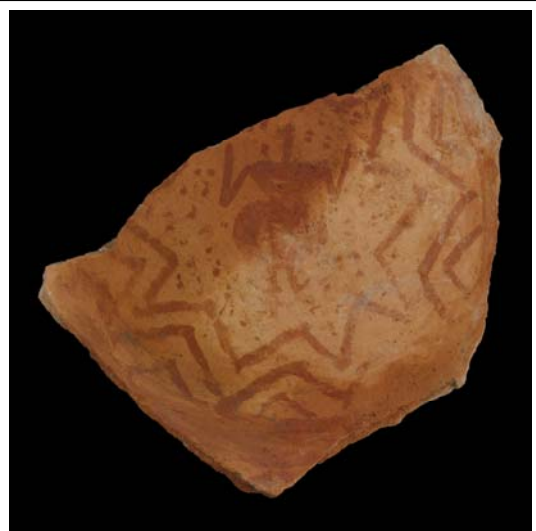
Figure 57: Bowl decorated with a human figure.
Photo B. Erdogu

One of the most interesting finds was a deep bowl decorated with a human figure (Figure 57) with upraised arms painted on the interior base of the bowl. The lower part of the figure seems to indicate that it is robed in a kind of skirt. It has short legs and long pointed feet that give the impression that the figure is wearing shoes. The figure has a long neck, and at first sight looks like a headless human figure, but the tiny head is probably relatively unimportant, instead stress is on the body.

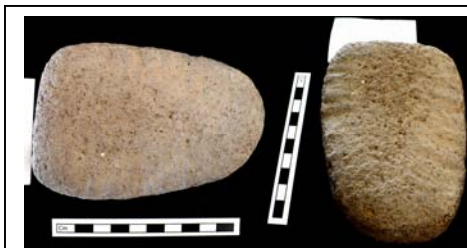
Quern 3 (ÇH07 West 8, (15513)) is an intact lower part of a grinding stone (L: 122, W: 81, T: 36) made of fine porous basalt (Figure 60). It is particular in the way we see the notches deliberately worked on its two lateral concave surface (inner surface). The aim of such a detail on the lateral borders of a stone tool would be to improve its friction power during the grinding process.

Figure 60: A complete lower part of a grinding stone from Tr.8 West. Photo O. Özbek

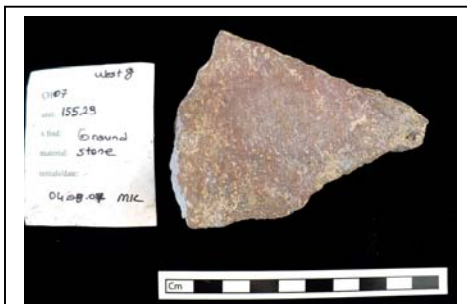
Quern 4 (ÇH 07 West 8, (15529)) is a fragment of a lower part grinding slab (L: 82, W: 66, T: 21). This piece is thin when compared to other grinding slabs and this may be an indication of other function than food production. The concave surface contains a red pigment residue which could be iron oxide.(Figure 61)

Figure 61: Fragment of lower part of a grinding stone from Tr.8 West. Photo O. Özbek

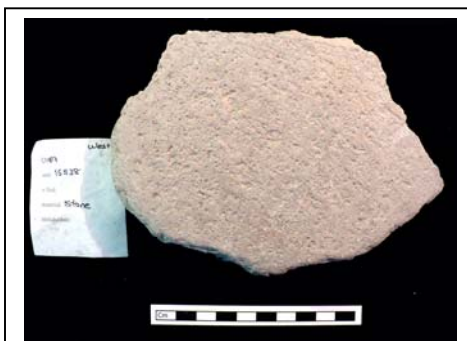
Quern 5 (ÇH 07 West 8, (15538)) is another fragment of a large grinding slab made of andesite broken nearly into half (L: 160, W: 275, T: 42). (Figure 62)

Figure 62: Lower part of a grinding stone Tr.8 West broken nearly into half. Photo O. Özbek

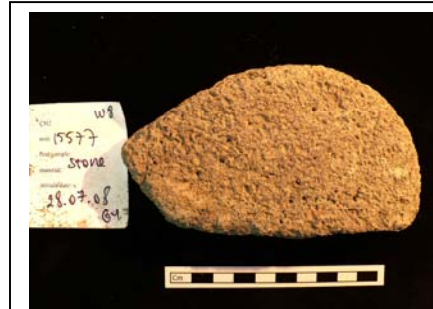
Quern 6 (ÇH 08 West 8, (15577)) is a lower fragment of a small grinding slab made of large grained volcanic rock broken nearly into half (L: 162, W: 146, T: 59). Its original form should have been a regular elliptical before it was broken. (Figure 63).

Figure 63: Fragment of lower part of a grinding stone Tr. 8 West. Photo O. Özbek.

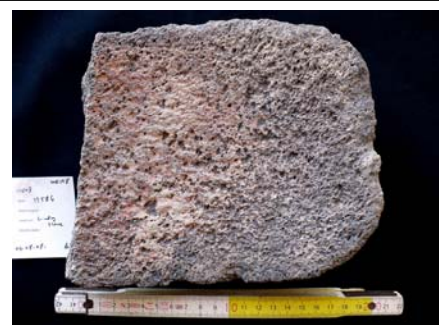
Quern 7 (ÇH 08 West, (15584 8)) is a regular quadrangular shaped grinding slab broken possibly into half (L: 185, W: 170, T: 50). It is made of porous basaltic rock and on the concave surface, there is still trace of a reddish pigment (Figure 64).

Figure 64: Lower part of a grinding stone Tr. 8 West broken nearly into half. Photo O. Özbek.

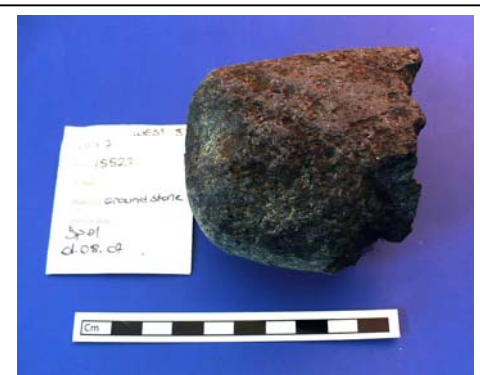
Pestle 1 (ÇH 07 West 8, (15527)) is the proximal extremity (the butt end) of a pestle (L: 78, W: 74, T: 55). The fragment has also pecking traces on its lateral sides. The proximal end has use marks that have been left during its second use may be as a hammer stone. The A and B sides of the artefact has not only friction but polishing traces, as well. It is made of a volcanic rock with feldspath inclusions however, the natural texture and patina was altered due to fire. The overall section form is very regular ellipsoid (Figure 65).

Figure 65: Fragment of a pestle from Tr. 8 West Photo O. Özbek.

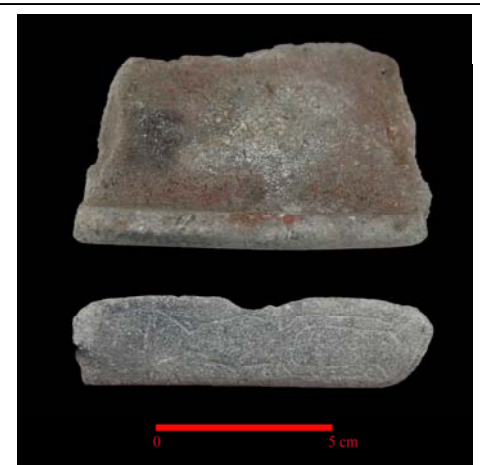
Stone vessel 1 (ÇH 09 West 8, (15588)) is a unique find found in 2009 (L: 98, W: 70, T: 34) (Figures 66 & 67). The find is a corner fragment of a rectangular stone vessel. The artefact had red pigment residue on the inner surface. During 2009 studies in Çatalhöyük, we owe our thanks to Dr. Tristan Carter who kindly helped us for X-ray fluorescence analysis . According

to the XRF results, the vessel had iron oxide (ochre) residue. The most important characteristic of this artefact is the incised decorations on the sides. The longest side of the vessel has a crayfish presentation. The inhabitants of modern villages around Çatalhöyük in Konya, indicate that crayfish could be found abundantly from Hotamış Lake and the streams connected to this lake. The shortest side of the vessel has also another incised schematic description rather of such an animal or has a geometric decoration; however, it is early to suggest what it is (Figure 66). The depiction of the crayfish is nearly 80mm in length and its tail section is incised in great detail. The vessel has a keel part like a boat broken from nearly middle part. The artefact should have two parallel keel parts prior to its fracture. The craftsmanship effort in the production of such a piece should have been great when the difficulty in shaping the porous frail raw material of this basaltic rock is considered.

Figure 66: Ashtray-like stone vessel with crayfish figure. Photo O. Özbek.

A broken ashtray-like stone vessel with incised decoration is unique. It contained traces of ochre on its interior surface, and a crayfish figure can be seen on its exterior surface (Figure 66). Up until recently crayfish were plentiful in fresh water lakes of Hotamış and Mamasın in Central Anatolia (Erdemli 1987).

Firstly, instead of presenting some overview statements on tool groups, it is better to discuss the most important ones as the crayfish (*Astacus leptodactylus*) depicted stone vessel and the two axe blades found together. As far as I know, a crayfish representation on a stone vessel is a unique event and should be discussed in terms of Late Holocene nutrition strategies of Central Anatolian human populations. This artefact should have been nearly half part of a stone tray of 10 x 15 cm size. The missing part on one rim of this piece which the incision on the stone is uncertain: some compelled imagination might indicate representations of crayfish hunt with these geometric drawings.

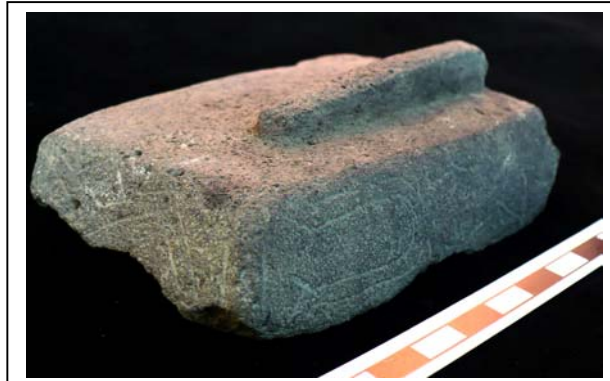
Figure 67: Corner piece of the ashtry-like stone vessel fragment with decorations on its borders. Bottom view: the carinated (keel) part. Photo O. Özbek.

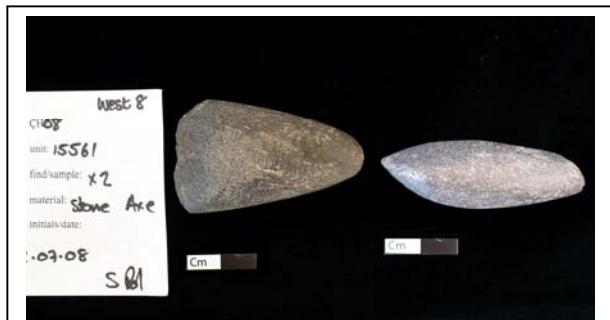
Axe 1 (ÇH 08 West 8 15561.x2) is a small diabase stone axe and it seems that the original piece was a transported material (secondary source) found in a river bed near the settlement (L: 54, W: 32, T: 17). The small cavity which could not be totally ground or polished on face B is an indication of its origin (Figure 68). About the production stages we can deduce the fact that the stone was directly polished and than only some limited part was pecked (Face B). As this pecking work is not observed on the lateral or proximal parts, the intention should not have been increase of the friction for the handle, if it was used with it. According to the general symmetry of the distal extremity from profile and its overall section at the same part of the tool, in typological sense we can say that it is an axe.

Figure 68: Polished stone axe 15561.x2. Left photo face A, right photo section. Photo O. Özbek.

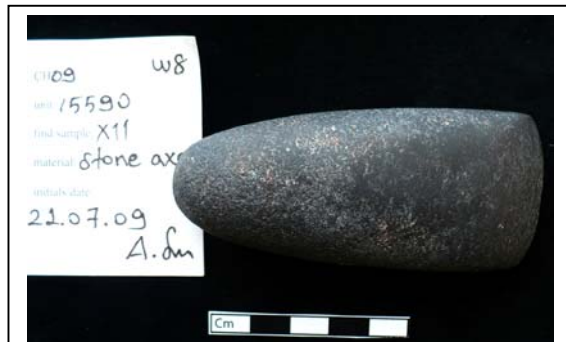
Axe 2 (ÇH 09 West 8 15590.x11)(L: 90, W: 40, T: 27) had distinct fire alteration marks like Axe 3 when it was found (x12). The tool is made of a very fine grained metamorphic rock but it is hard to tell the type because of the heavy alteration and colour loss (Figure 69). The only mineral identified was feldspath. The pecking operation after polishing is absent on the A and B surfaces of the distal extremity. The distal part was quite sharp and apparently there is no use trace. However, on the both lateral parts and A and B faces, intense pecking is observed. Another detail on Axe 2 is the polishing attempt on the pecked surface which is not very common for a functional, usual everyday implement. The proximal extremity (butt) is smoothly worked and rounded. The

Figure 69: Polished stone axe 15590.x11. Photo O. Özbek.

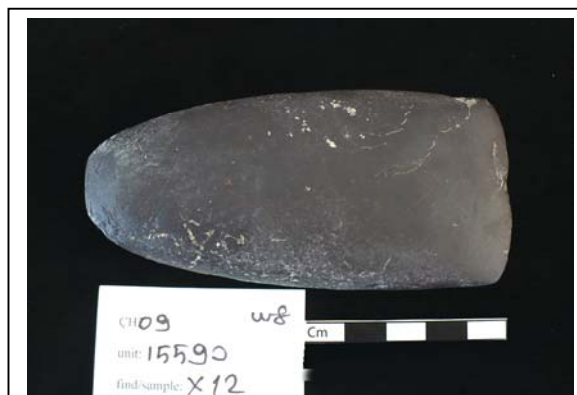
Axe 3 (ÇH 09 West 8 15590.x12) is different from Axe 2 only in length (L: 102, W: 44, T: 22). The artefact resembles morphologically to Axe 2, in general (Figure 70). Other difference is that there is less pecking spots on Axe 3 than Axe 2. Although no use-wear traces are observed on Axe 2, Axe 3 has some chipping marks on the A face of the blade. The B face is also notched slightly. In general, it seems that the artefact is in its final production stage and no re-sharpening traces are observed on the distal extremity.

Figure 70: Polished stone axe 15590.x12. Photo O. Özbek.

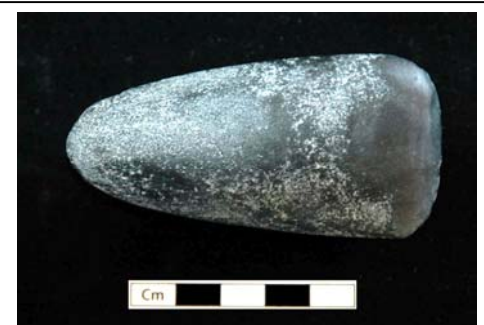
Axe 4 (ÇH 09 West 8 18205.x4) is close to Axe 2 in general form (L: 82, W: 42, T: 22). This artefact has more pecking traces on its A and B surfaces (Figure 71). Although most of the surface is covered by pecking, the distal extremity is left smoothly polished. The proximal extremity is carefully rounded. There is fine chipping marks but it is difficult to distinguish from use wear. This artefact too, can be called as axe in morphological sense.

Figure 71: Polished stone axe 18205.x4.
Photo O. Özbek.

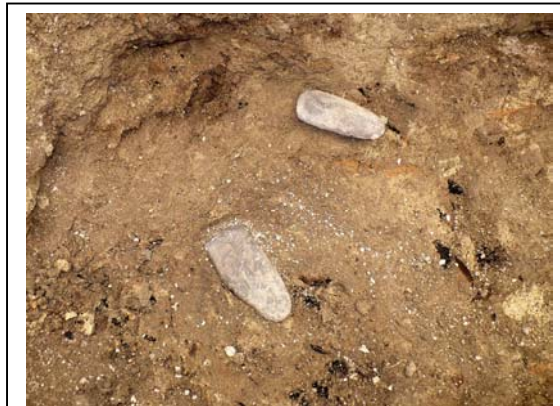
In summary, the artefacts Axe 2 and 3 merit our attention because of their depositional context. They were both found horizontally, only 0.2m away from each other with similar posing directions towards North (Figure 72). In terms of raw material, both were produced from similar metamorphic rocks: metabasites, possibly. They are not very different in general morphology although there is little difference in size. Both had fire alteration traces and found near carbonized objects. Our first impression was that they were put together with different items made of wood. Another hypothesis is that they might have been put into wooden box as these carbonized residues were found in a linear position but irregularly. One thing definite for us was that these two axe blades were placed here without their handles whether of wood

Figure 72: Axe 2 and 3 when found at U15590 in relation with carbonized residues. (Photo O. Özbek.)

or other material. The reason is that although there were unambiguous traces of carbonized wood only some few centimeters away from these axes, there was no carbon evidence on the artefacts.

Secondly, the two axe blades found together with unambiguous evidence that they were deposited and reserved for a certain purpose in the future whether functional or exchange, merit further debate. This initial analysis will be developed in the forthcoming studies about Tr.8 Çatalhöyük West.

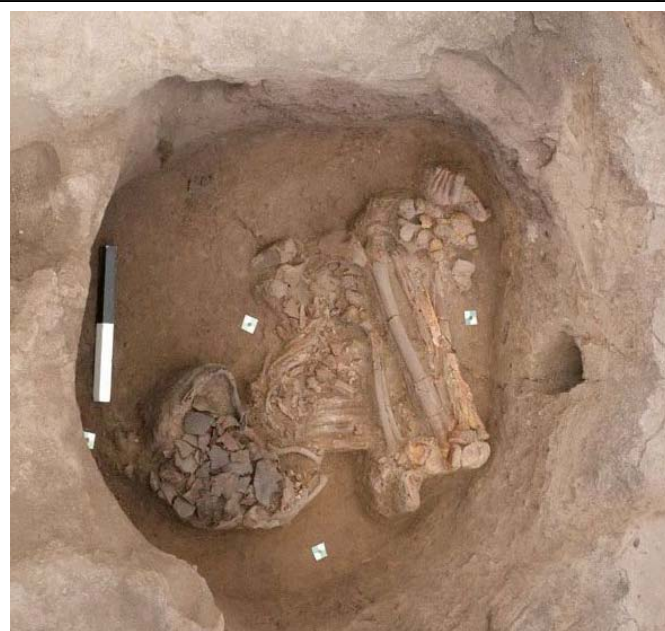
Figure 77: Early adolescent F. 3416, Sk (18447) in East Platform of B 76. Note blackened and fractured skull. The blackened mandible of Sk (18701) is visible next to the skull of Sk (18447). View north. Photo Human Remains Team.

The individual was a young adolescent of ~ 12 years of age at the time of death. The grave cut was distinct in the platform floor. The body was oriented with the head to the southwest and the main axis of the body southwest-northeast (Figure 77). The east-west length of the grave was constrained relative to the length of the body, resulting in a tight fit within the grave. The flexed feet extended up the wall of the grave as the body's highest point. Consequently, some of the distal foot phalanges were carbonized due to their proximity to the surface of the platform. Likewise, the head and upper neck/shoulder area were baked brown-black due to their proximity to the hottest part of the fire. All the bones were highly fragmented but the skull bones were particularly fractured due to the heat. Many of the teeth were shattered. The post-cranial bones were fire altered but not blackened.

The mandible of another individual, Sk (18701), was located adjacent to the head of Sk (18447) (see Figure 77). This shows that the interment of Sk (18447) disturbed the mandible of Sk (18701).

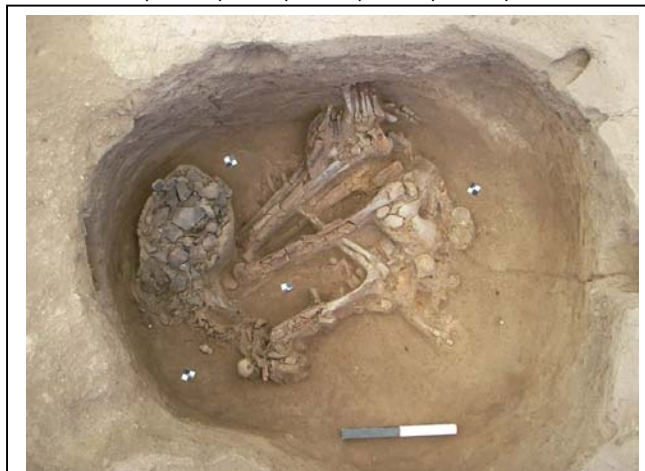
Figure 78: Adolescent F. 3419, Sk (18464) from East Platform of B. 76. Note fragmented and blackened skull and upper body. Some distal phalanges of the foot were also carbonized. The skull of Sk (18701) is next to the skull of Sk (18464). View north. Photo Human Remains Team.

Located directly under Sk (18447) in the east Platform of B.76, Sk (18464) was an adolescent of ~15 years at the time of death. Dental development and eruption patterns in addition to the state of the epiphyseal union of several bones suggest an age of late adolescence. Sex is indeterminate.

The flexed body was on its left side with the head to the southwest (Figure 78). The head was facing east, also on its left side. The right arm crossed the chest, interlaced between the legs. The left arm was extended towards the feet. The feet were up against the wall in a

flexed position. Some of the distal foot phalanges were carbonized. A small clay figurine (18465.x1) was found next to the cervical vertebrae. The figurine may or may not have been directly related to the skeleton.

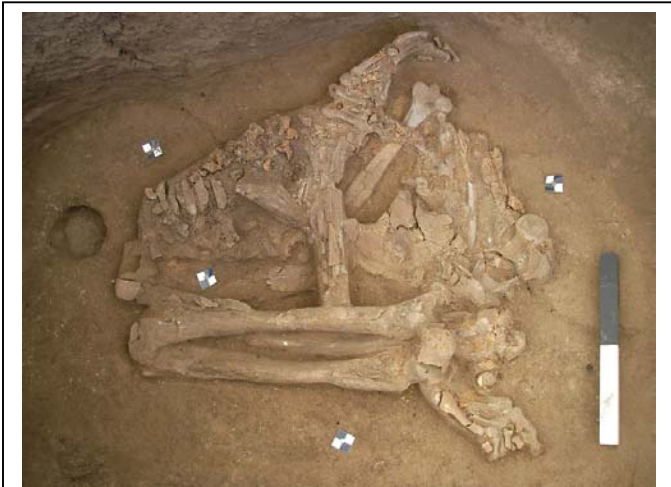
Figure 79: Adult male F. 3422 Sk (18701) in E platform of B. 76. The displaced cranium was found with F.3419 Sk (18464) in the level above while the displaced mandible was found with F. 3416,Sk (18447) in the uppermost level. View N. Photo Human Remains Team.

The body of Sk (18701) was flexed on its right side with the inferred head position to the west and the feet to the east (Figure 79). The position and orientation of this individual closely matched the position and orientation of the two upper individuals ((18447) and (18464)). The right shoulder may have also been displaced given that it was slightly out of anatomical position. The right arm was under the skeleton, bent slightly at the elbow with the hand extended under the pelvis. The left arm was extended on top of the left femur, bent acutely at the elbow with the lower arm crossing the abdomen and the hand extended along the northern section of the grave pit. The legs were tightly flexed at the hip and knees with the knees near the chin. The feet were extended in the southern part of the pit.

The skull, mandible, knees, and upper ribs and vertebrae were baked and blackened by the heat of the fire in the building. The lower body was fire altered in the same manner as the other 2 individuals above it: the bones were friable and in poor condition with the cancellous bone orange. Like all of the B.76 skeletons, carbonized organic materials, possibly brain tissue, were found inside the cranium of this individual.

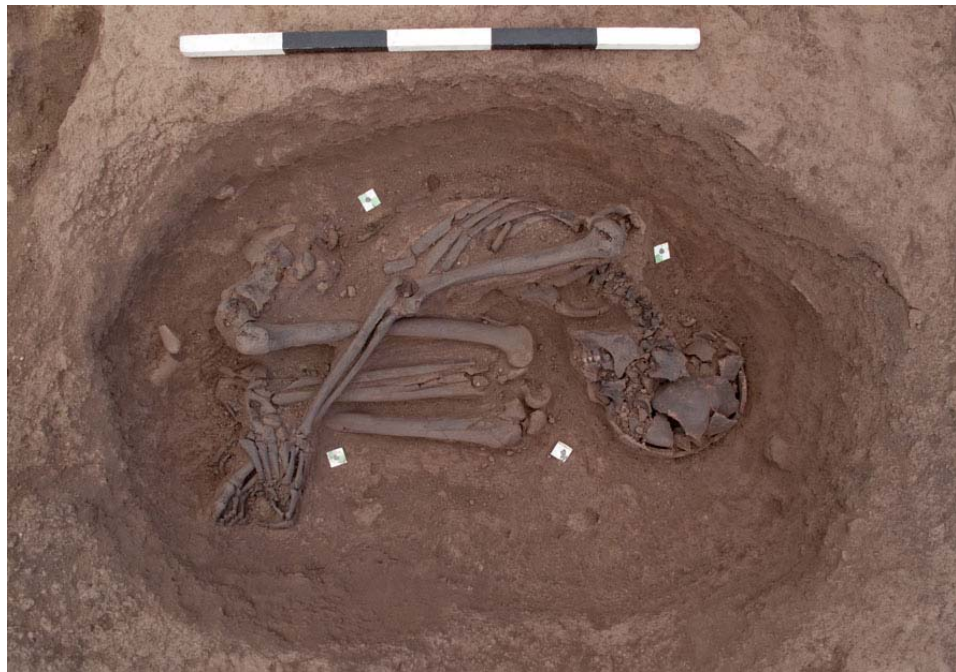
Figure 80: Young adult female F. 3418, Sk (18457) from NE Platform in B. 76. Note the extent of the blackening to the skeleton. View east. Photo Human Remains Team.

F.3418 is a Neolithic primary grave under the northeast platform of Building 76 containing a single adult female skeleton (18457) (Figure 80). Assessment of sex is based primarily on cranial and mandibular morphology as the pelvis is in poor condition. The sciatic notch, however, does appear morphologically female. All epiphyses are fused. Based on the pattern of occlusal dental wear the age of this individual can be placed between 25 and 35 years.

The bones of this skeleton have been baked a dark colour as a result of the fire that consumed Building 76. Some parts of the skeleton, like the hands and feet, cervical vertebrae and the skull are very black. The parts of the skeleton farther from the heat source (e.g., left limbs) are dark brown. The body may still have been at least partially fleshed when the burning event took place, as certain parts of the skeleton that would have been insulated from the fire by soft tissue (e.g., lumbar and thoracic vertebrae, elbow joints, etc.) show the least amount of darkening. Blackened organic material recovered from inside the cranium may be carbonized brain tissue. If this does turn out to be brain tissue, it strengthens the argument that the body was still at least partially fleshed when the fire took place, as the brain tissue would have decomposed completely in the absence of fire.

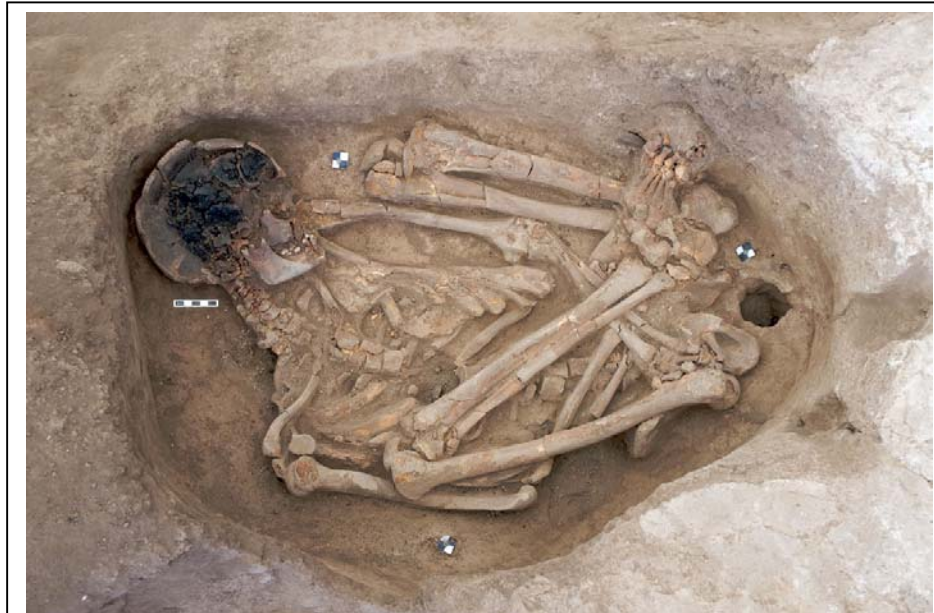
Figure 81: Young adult male F.3421, Sk (18496) from NE Platform in B. 76. Note the blackened skull and the carbonized organic material endocranially. View north. Photo Jason Quinlan.

Placed on its back with the legs tightly flexed, the body was oriented with the head to the west and the feet to the east (Figure 81). The head was bent towards the northwest, possibly as a result of the abbreviated east-west length of the grave relative to the size of the body. The head was on its left side, facing east. Fragmented and blackened, the cranium had a large amount of the carbonized organic material, possible brain tissue, which was found in the other 4 skulls from B.76 (Figure 82). Both arms were extended with the elbows bent slightly and the hands at the pelvis. The knees were laterally placed to the left and right of the chest region, respectfully. The feet were together at the northeast edge of the grave pit. The post-cranial skeleton was in poor condition. A worked flint tool (18465.x1) was found near the feet.
