ÇATALHÖYÜK 2009 ARCHIVE REPORT

Çatalhöyük Research Project

*Archive Report 2009 compiled by Shahina Farid
Photos by Jason Quinlan (unless specified)
Plans by Cordelia Hall (unless specified)*

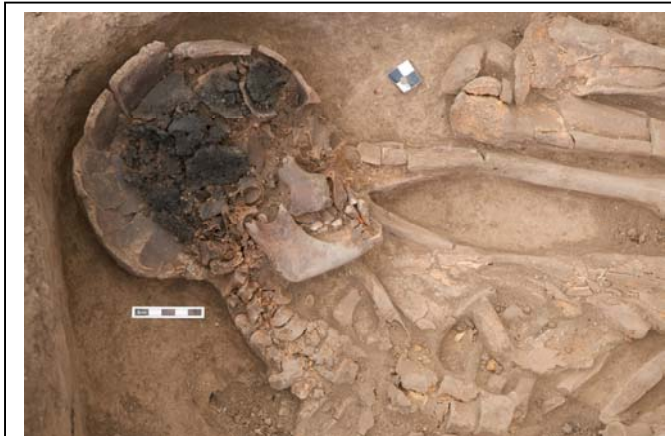
Figure 82: Close-up of the inside of the blackened skull of F.3421, Sk (18496) showing carbonized organic material in situ. Photo Jason Quinlan.

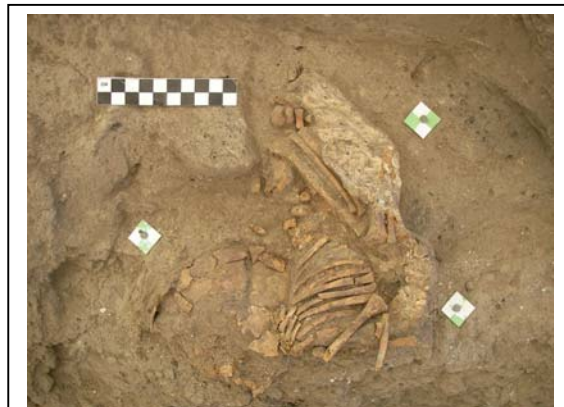
Figure 83: A neonate, F. 4076, Sk (14818), in a lidded basket placed in the lower level of B. 53, view southeast. Note the thick layer of phytoliths. Photo Human Remains Team.

A neonatal skeleton (14818) was found eroding out of the North wall of Building 53 (Figure 83). Given the amount of erosion this area has experienced since the skeleton was first noted in 2007, a surprisingly large amount of the skeleton remained intact. The flexed skeleton was placed on its left side with the head to the north, facing east. Phytolith remains were found above and below the legs, lower back and skull, suggesting that the baby was placed in a covered basket for interment. Cause of death was indeterminate. No grave goods were found.

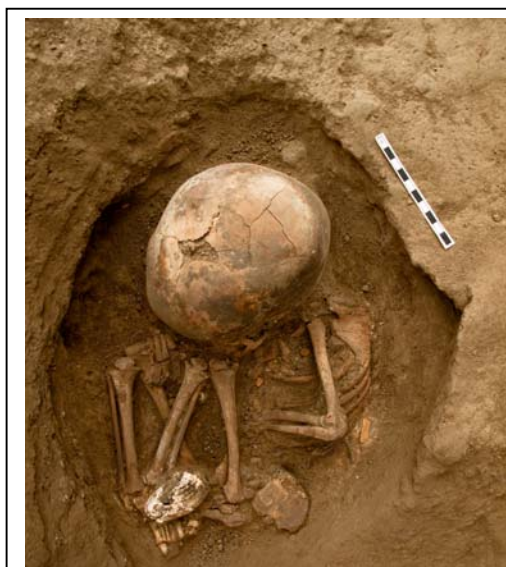
Figure 85: F. 4028, Sk (17939), a ~2 year old child skeleton, the earliest burial in the NW platform of B. 49. The shell (17938.x1) in the foreground contained red pigment. View S. Photo Human Remains Team.

The skeleton was tightly flexed on its left side and oriented with its head to the south and feet to the north (Figure 85). The child was likely placed in a reed basket, as there are thick phytolith remains, some with traces of the basket weave, directly underneath the skeleton (Figure 86), as well as at the sides of the cut. Phytolith remains were also found on the cranium. A large shell (17938.x1) containing red pigment on the inner surface was placed above the feet/ankles of the skeleton.

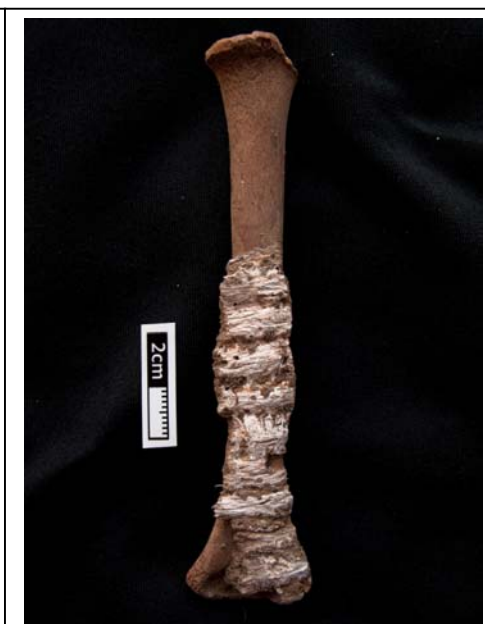
Figure 86: Right humerus of F. 4028, Sk (17939) showing thick layers of phytoliths. Photo Human Remains Team.

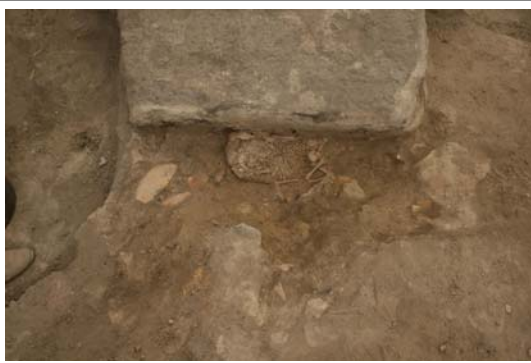
Figure 87: A neonatal skeleton, F. 3300, Sk (18333), from the Chalcolithic of the West Mound, Trench 5, view north. Photo Peter Biehl.

One Chalcolithic burial (18333) was found this year from the West Mound in Trench 5. The complete and fully articulated skeleton of a neonate was found next to a wall buttress (F.5061) in the northern part of Space 342 (Figure 87). The neonate was positioned on its stomach in a flexed position with the head to the west and feet to the east (Figure 88). There is no apparent cut or distinguishing fill in association with the neonate, suggesting the burial was included as part of the room fill in this space. Remnants of phytoliths were found over the body and were taken for a sample. The presence of the phytoliths indicates that the neonate had been placed in a basket at the time of interment.

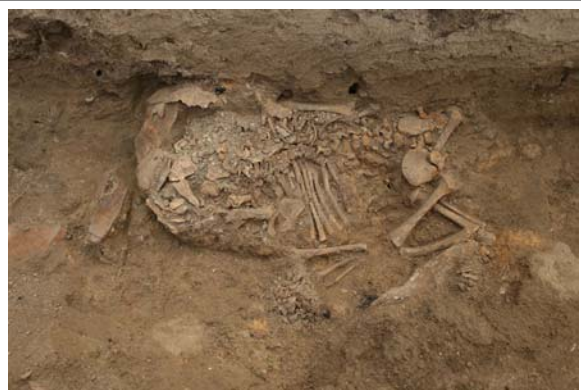
Figure 88: Close-up of neonatal skeleton, F. 3300, Sk (18333), view north. Photo Peter Biehl.

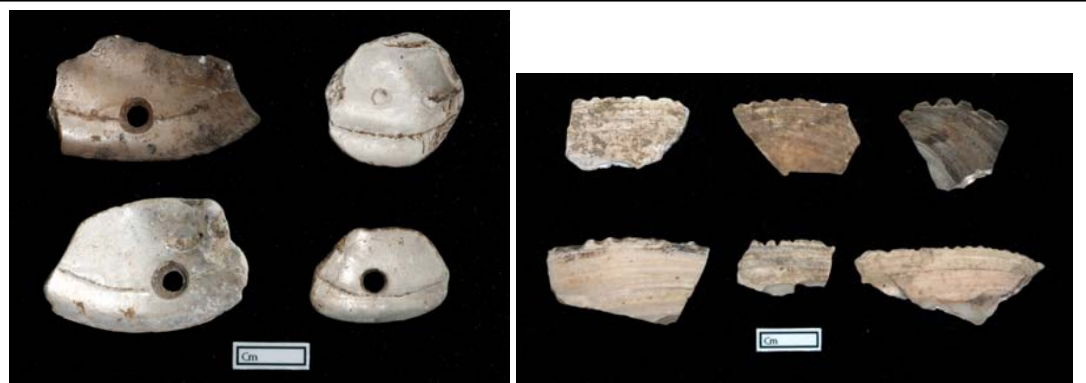
Figure 91: (left) Pendants made of *Unio* shells. Note the natural pallial line (right) Serrated artifacts made of *Unio* shells. Photo Jason Quinlan.

assume that the holed pendants were used as personal ornaments. The presence of a group of them in the context of a burial supports this. Most pendants had one hole, but others had two, and in one case there were three holes (n=108). We also found a number of “blanks” that had the same general squarish contour and dimensions but were not perforated. Many of these pendants were cut from the thicker part of the shell near its margin, and the pallial line is clearly visible on them. Many of the holes were perforated on the pallial line or slightly above it (Figure 91 left), usually from the inside nacreous surface of the shell outwards. The serrated artifacts (n=7) were usually cut from the margin of the bivalve, and the serrations were incised about 1-2 mm apart. Some are worn as a result of use (Figure 91 right). Those could have been used for pottery decoration, but similar artifacts, it has been suggested, could have been “fish scalers” (MacDonald 1932).

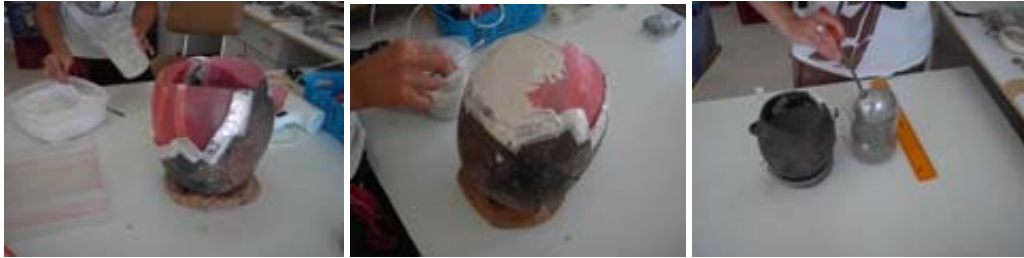
Figure 97: Restoration for experiment for vessel capacity. Photo Pot Team.

This operation started by completing missing parts of vessels and then filling the gaps and holes with silicone material after the edges of the application area were covered with masking tape and then plaster applied (Figure 97)

The completed vessels were filled with sand up to 2cm left to the rim. The sand measured with a scaled cup.

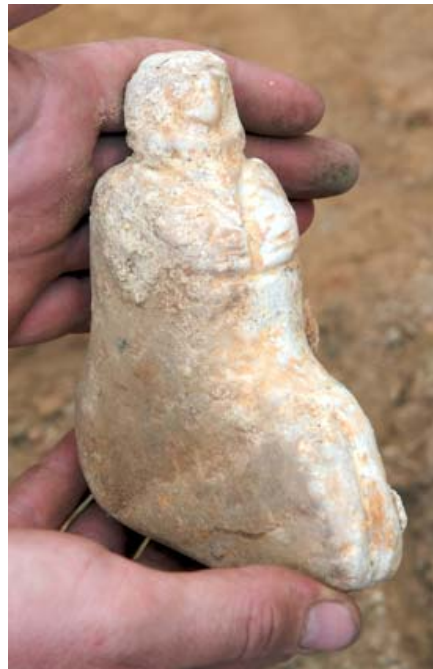
Figure 98: Figurine 18523.X1—limestone figure of bearded man located in house fill of B.79. Photo Jason Quinlan.

Figurine 18523.X1 (Figure 98) was located in house fill in Building 79. It is a free-standing limestone figure of bearded man, with important parallels from Mellaart's excavations. Its basic shape is a triangular seated or reclining form that is moderately carved or possibly unfinished. The face is largely comprised of a protruding nose and lightly marked holes for eyes. The distinguishing feature is the hair and beard such as Ankara examples 79-457-65 and 79-191-65. The closest parallel is Ankara 79-455-65, which is almost identical in terms of decoration, size, and shape. There is a band around the forehead that extends to the back, possibly a headband. There is also a groove extending from the front to back of the head. Below the head and directly onto the chest area is a deeply incised V, similar to the images carved at Göbekli and Nevalı Çori. Only the block form indicates a body shape and the stomach area was not delineated. The arms are incised and shortened, facing front with fingers roughly indicated. A deep incised line runs under the arms but not all the way around to the back. The legs are indicated by a frontal groove resembling the legs of 79-801-65 in Ankara; they are thin and not naturalistic. From the back the figurine appears as simply a head and column shaped body. Its dimensions are 12.02 cm high, 10.44 cm wide and 4.5cm in thickness, weighing 152 grams.

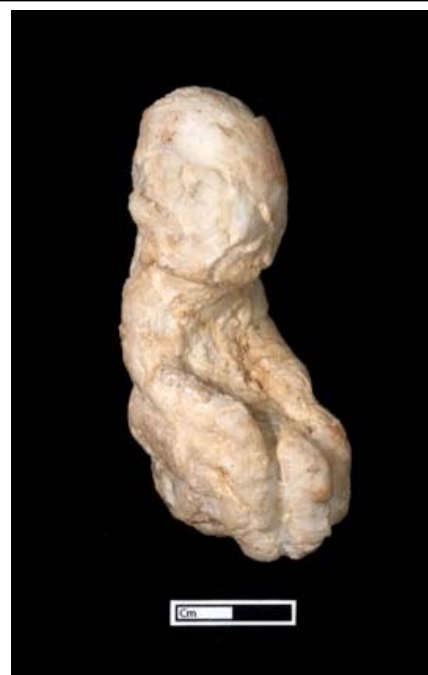
Figure 99: 18545.X1—a tall marble figure (21.8 cm) seated on a base. Photo Jason Quinlan

Significantly, 18545.X1 (Figure 99) also comes from Building 79 house fill. It is a seated figure on base with small animal head protruding between the legs, carved from limestone. The human portion has an overly large and disproportionate head. Facial features are minimal and there is damage, however, the ears are pronounced. There may be evidence of a carved nose and a slit for the right eye. This was harder to tell after consolidation. The chest area is concave and the figure leans to the right. Arms on either side are outlined and the sit upon the thin, carved legs. The left arm appears longer than the right. Neither hands nor feet are carved. At the front one can clearly see the animal head and outlined body between the legs, lending a phallic quality to the piece. Before conservation the eyes of this animal head were more visible. To the sides and back you can see the shaping of the buttocks and legs, whereas the head and back are not detailed and form one simple column. Given the helmet like shape of the head, the view from the side is rather phallic. From the back one can see the ears sticking out. There is a slight nick in the base of the figure at the front to designate the overlap of the legs and the animal body or base that the figure sits upon.

of 10264.X1 that is almost Cycladic in shape: the emphasis is upon the nose. The head area is the least naturalistically worked and is too large for the body. Parallels from prior excavation in the 1960s include animal riders like 79-167-65 and 79-457-65. The closest parallel in shape and design, albeit much larger, is 79-801-65, a tall marble figure (21.8 cm) seated on a base. While it has no animal head protruding it does have a detailed, raised and whitened area between the legs, which may indicate a penis? There is no evidence of paint on 18545.X1. The overall effect is of a lumpy, disproportionately carved figurine. It may have been modified from a selected stone that already had some suggestive shape.

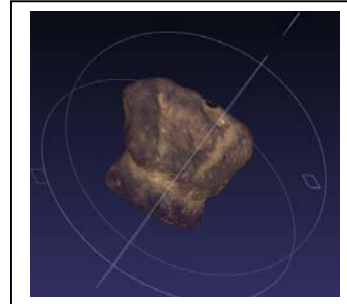
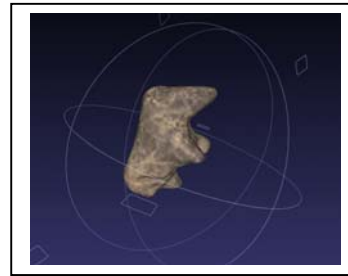
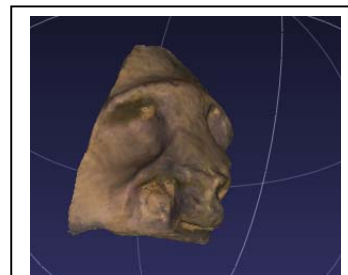
Figure 100: 3D laser scans.
Image Maurizio Forte & Claudia Luizza

Representations: We were also fortunate enough to have the expertise of Professor Maurizio Forte (UC Merced) and Claudia Luizza (Stanford) who conducted 3D laser scans of numerous figurines with a portable object scanner (Figure 100). The aim of this work was to add another dimension to the visualization project that we have been interested in from the outset. Instead of focusing on 2D renderings, we have wanted to explore the material qualities of figurines for holding, handling, circulating and manipulating. Another benefit of the scanning technique is that viewers can view and rotate the figurine in all directions, as well as enlarging it, to ascertain aspects of manufacture and composition. The free Opensource software used was Meshlab (for Mac and PC) and we hope to make these scans available online through the Çatalhöyük project website and the Stanford Figurines project website.

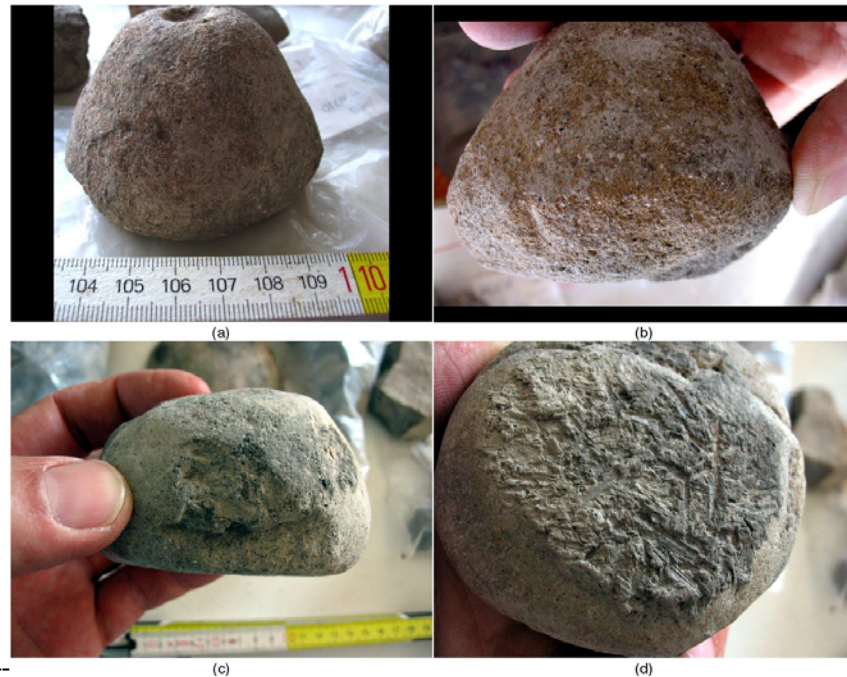
Figure 102. Cone-shaped KOPAL clay objects, showing typical gritty fabric (b), flat bases resulting from percussion and / or abrasion (b,c), and adhering clay-phytolith mix on the flat surface only (d).

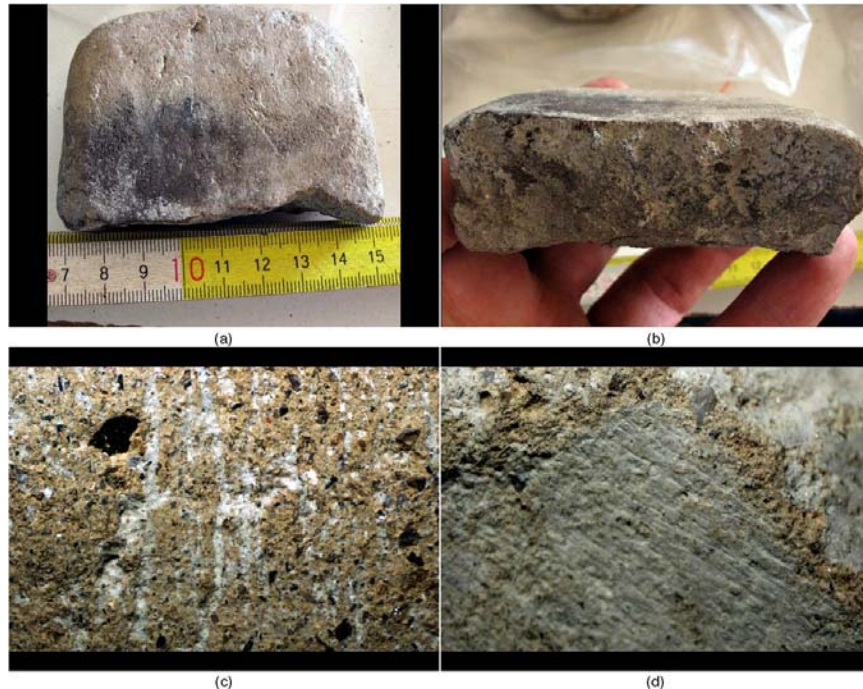
Figure 103: Rectangular KOPAL clay object (a), showing a central saddle (b) which is worn though the thin oxidation layer, wear marks infilled with plaster (c) which are parallel to the long axis and saddle, and areas of adhering plaster, also with wear marks (d). Photographs (c) and (d) courtesy of Jason Quinlan.

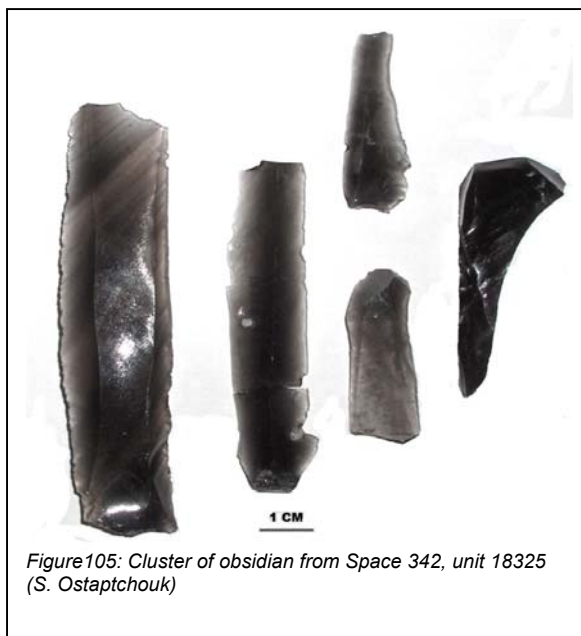
Figure 105: Cluster of obsidian from Space 342, unit 18325 (S. Ostaptchouk)

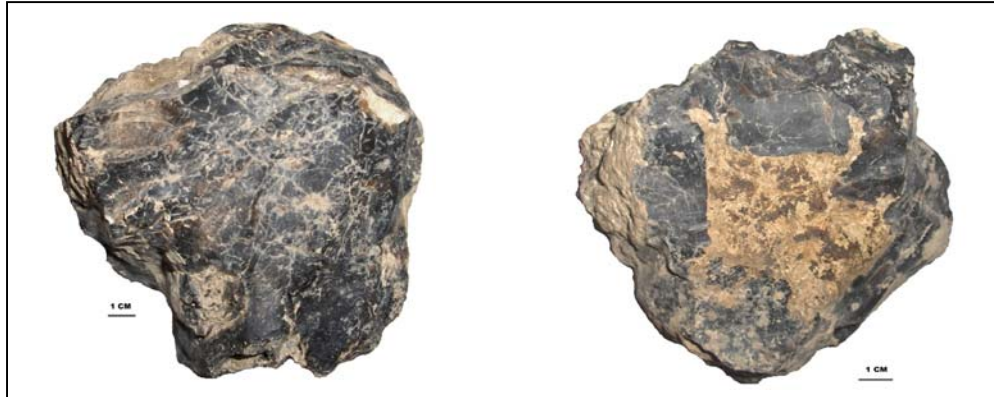
Figure 110: Large (5 kg) chunk of flint 18343.X7, Space 310, Trench 5 . S. Ostapchouk.

One notable find from Space 310 was a large chunk of 'flint' (18343.X7), weighing 5 kg it is dark brown and of poor knapping quality (Figure 110). There are 11 irregular flake scars around the chunk / core. Given the size, the presence of cortex and its poor quality it may follow that the raw material is local to the Konya Plain. It has a similar appearance to small cores found in Trench 8.

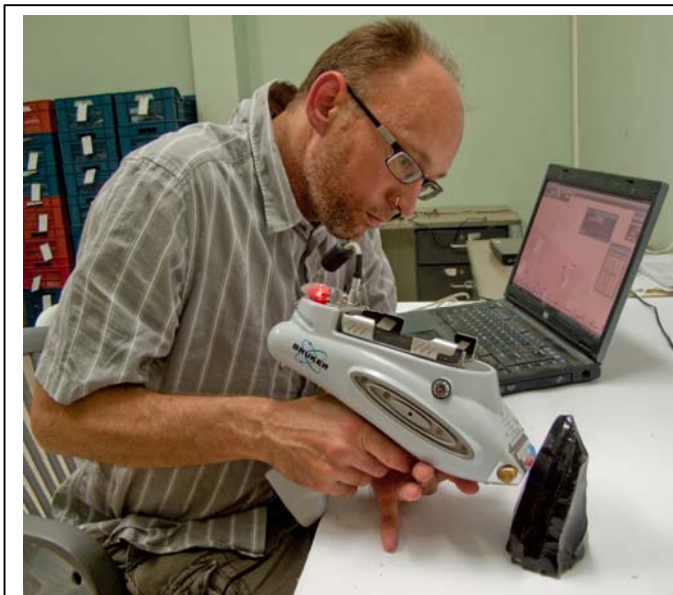
Figure 111: Elemental analysis of a large obsidian blade core from the surface of the West Mound using the Bruker Tracer III V portable X-ray fluorescence [PXRF] spectrometer . Photo Scott Haddow.

make our artefacts. For the first time this work was actually done at Çatalhöyük, through the use of a portable X-ray fluorescence [PXRF] spectrometer, specifically a Bruker Tracer III V, that was graciously lent to T. Carter by Bruker's Bruce Kaiser. We are currently processing this large amount of data (normalising spectra etc) and will publish the results in due course. The major benefit of having the instrument with us on site is that it enabled us to characterise those large and special artefacts that (a) are not allowed to be exported for analysis, (b) are often too thick to provide us with the edge translucency that we usually rely on to make visual source assignments (Figure 111).

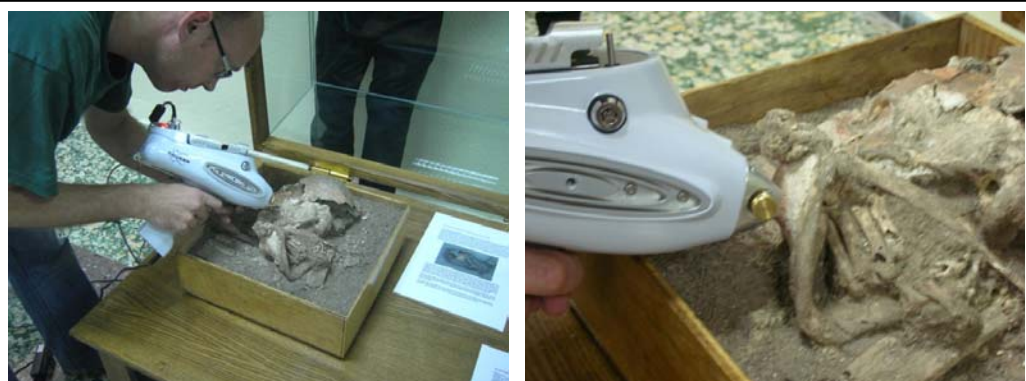
Figure 112: PXRF analysis of the plastered skull (11330) from Building 42, South Area, in Konya Museum. Photo Nurcan Yalman.

Plastered skull (11330) – from Building 42 in the South Area, excavated in 2004 (Boz and Hager 2004), is plastered from forehead to chin, with a background of white plaster painted with a red pigment. The skull has been on display in Konya Museum since 2004 and has never previously been analysed. With full permission from the curator we were allowed to use the PXRF to elementally characterise the red pigment in the gallery (Figure 112). The analyses were conducted at 40 keV, 5 mA, using a 0.076-mm copper filter and 0.0305 aluminum filter in the X-ray path for a 100 second live-time count. Firstly we analysed an unpainted surface of the skull to gain a background 'natural' reading of the skeletal composition against which we could contrast that produced by the painted surface (Figure 113). The results indicate that the pigment is iron-based, i.e. an ochre.

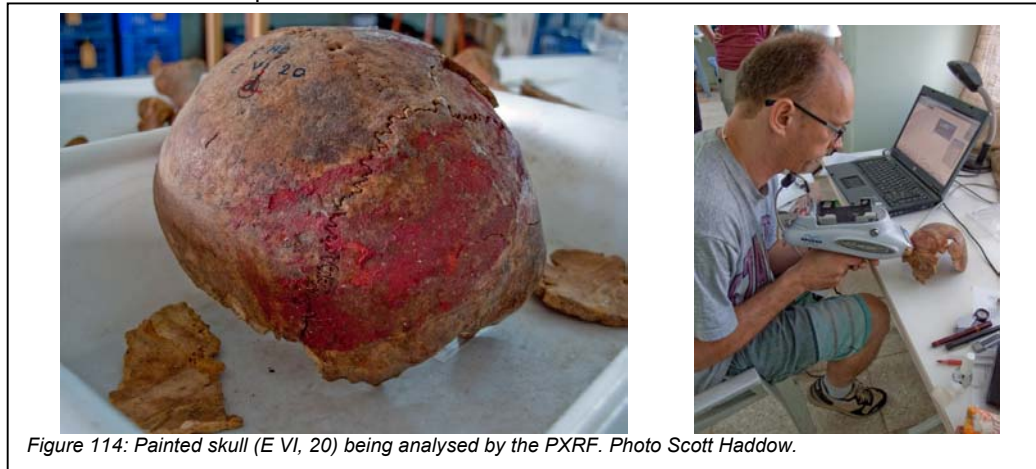
Figure 114: Painted skull (E VI, 20) being analysed by the PXRf. Photo Scott Haddow.

Painted skull (E VI, 20) – we also analysed a number of the renowned red-painted skulls from the 1960's excavations, including one from Level VI that had large frontal areas of a bright red pigment (Figure 114). The PXRf analysis, using the same method detailed above, confirmed clearly Mellaart's original claim that this vibrant colorant was the highly toxic cinnabar (HgS), a mercuric sulphide.

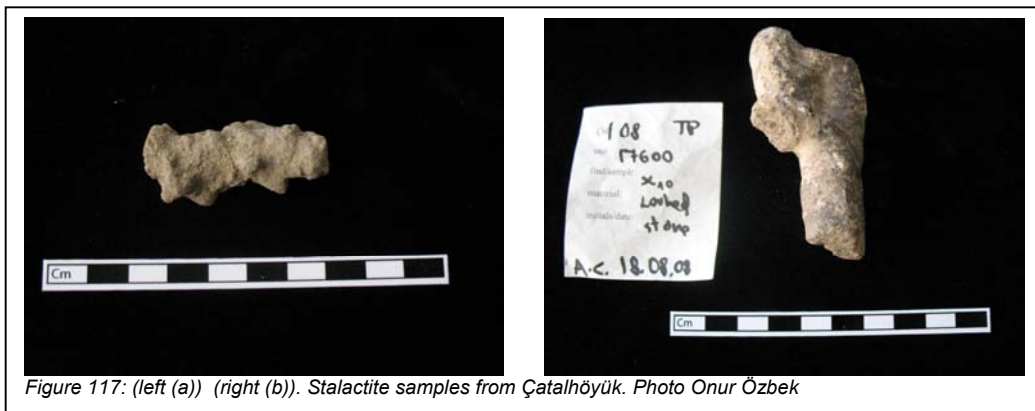
Figure 117: (left (a)) (right (b)). Stalactite samples from Çatalhöyük. Photo Onur Özbek

- 1-x.find number (16253), South, 16,08 gr. 4,60x2,10cm, stalactite. (Figure 117a)
- 2-x.find number (17600), T.P., 74,92 gr. 7,82 x 3,69 cm, stalactite. (Figure 117b)
- 3-x.find number (12357), 4040, 41,58 gr. 7,1 x 3,7cm, flow stone.
- 4-x.find number (13342), South, 44,93 gr. 5 x 3cm, dog-tooth spar.
- 5-x.find number (13405), 4040, 85,30 gr. 5,60 x 3,3 cm, stalagmite.
- 6-x.find number (16253), South, 16,08gr. 4,60 x 2,10 cm, dog-tooth spar.

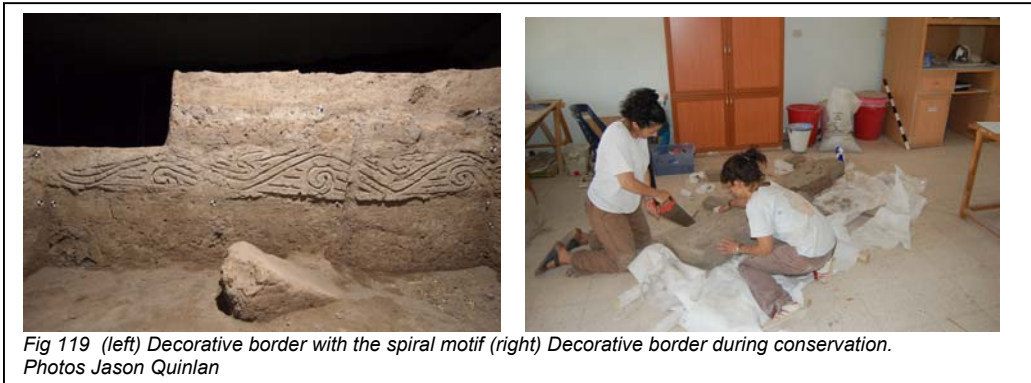
Fig 119 (left) Decorative border with the spiral motif (right) Decorative border during conservation. Photos Jason Quinlan

In the 2008 season, the conservation team undertook the most complex and heavy lifts of the last five seasons: The wall border with a spiral motif decoration, which surrounded three walls of a small room in the TP Area (Building 74, Space 327), found during the 2007 season (Figure 119 - left). The spiral motif decoration was incised on mud plaster, which was applied on the surface of the mudbrick walls and appeared to be eroded in places. After being lifted and the immediate conservation work was undertaken (see 2008 Archive report), the wall border stayed in the conservation lab until the 2009 season when its conservation continued and it was prepared to be taken to Konya Archaeology Museum for display (Figure 119 - right).

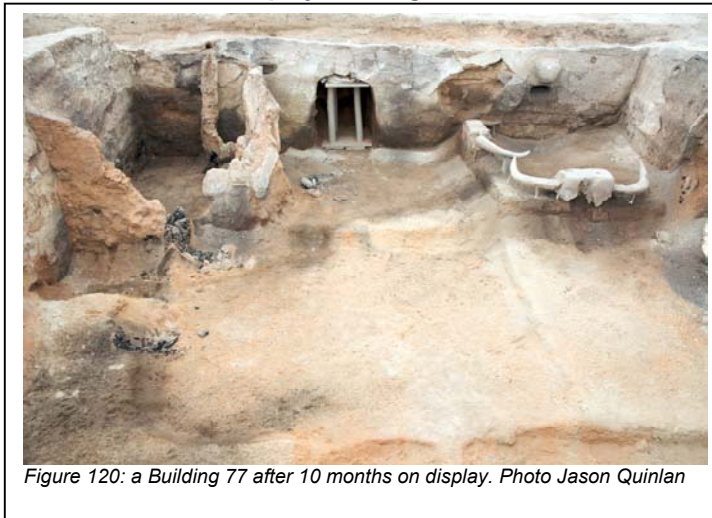
Figure 120: a Building 77 after 10 months on display. Photo Jason Quinlan

This season, visual observations and continuous environmental monitoring showed that it will be a very difficult process to preserve the buildings (specially the burnt and therefore more vulnerable than the unburnt buildings) under a macro environment of the 4040 shelter for a

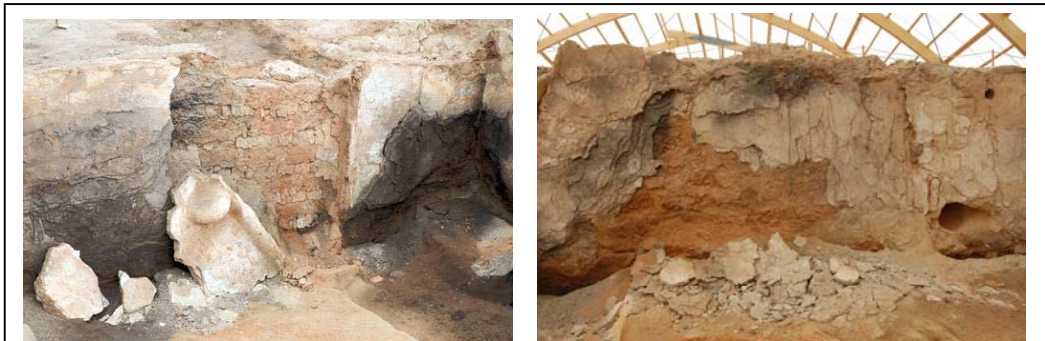
Figure 121: (top) Building 77, (bottom) Building 52. Photos Jason Quinlan.

protracted period of time, due to the drastic environmental change from buried to exposed buildings. One of the main problems over the last 12 months was the fluctuations in RH (Relative Humidity) causing a regular action of drying/wetting which activates the soluble salts through the ground water causing mudbrick and plaster layers to constantly erode, delaminate and detach. There was also much damage from small burrowing animals causing physical damage to the structures and the features (Figure 121)

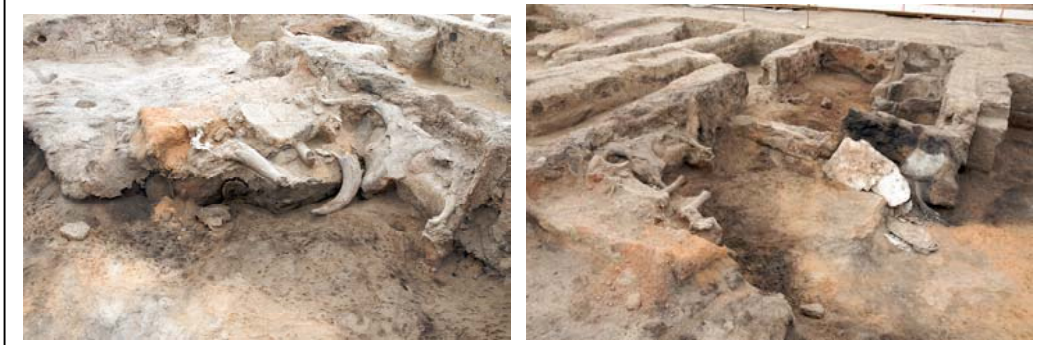
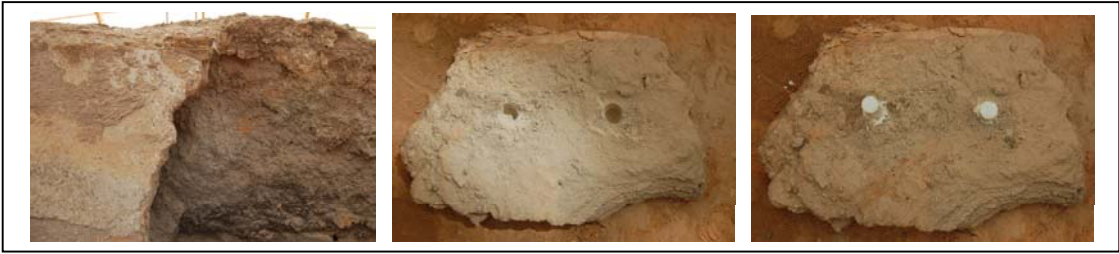
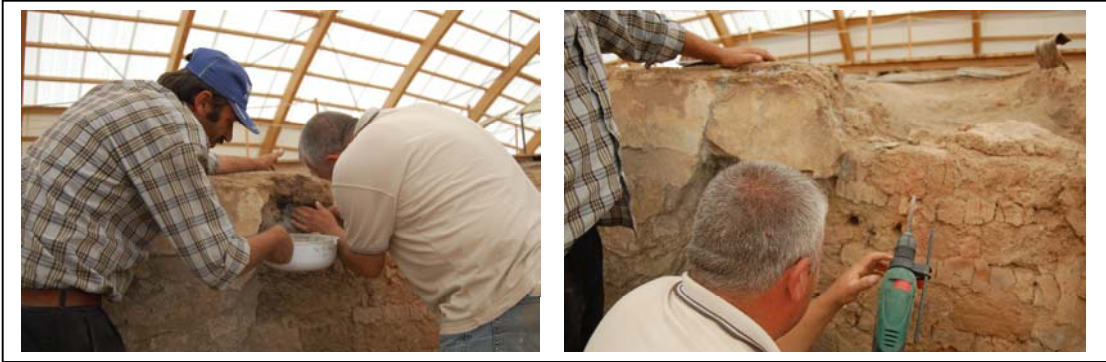
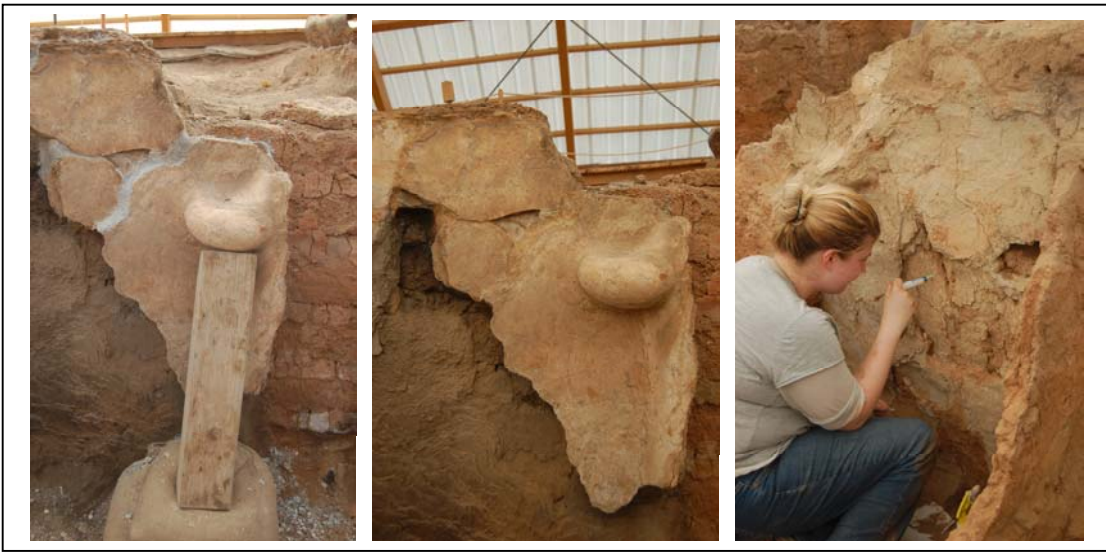
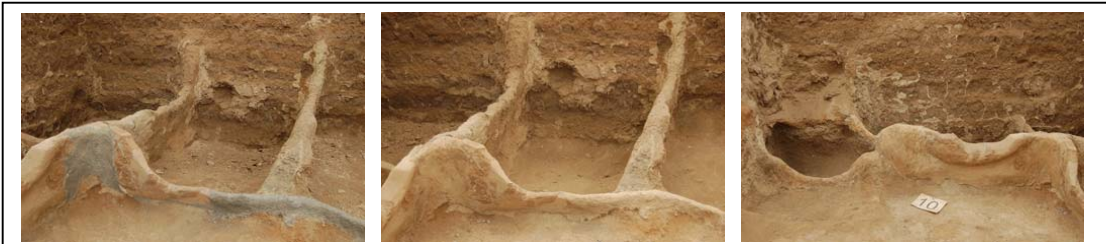
Figure 122: Stages of conservation. Photos Jason Quinlan.

structures will be inevitable and therefore the current buildings should be displayed maximum for three years which afterwards should be excavated down to the levels below. During the three years period, we will continue conserving the 4040 Area buildings in the usual way, but we may also need to make changes to the 4040 shelter in order to alter some of the impracticalities that it currently presents (Figure 122).

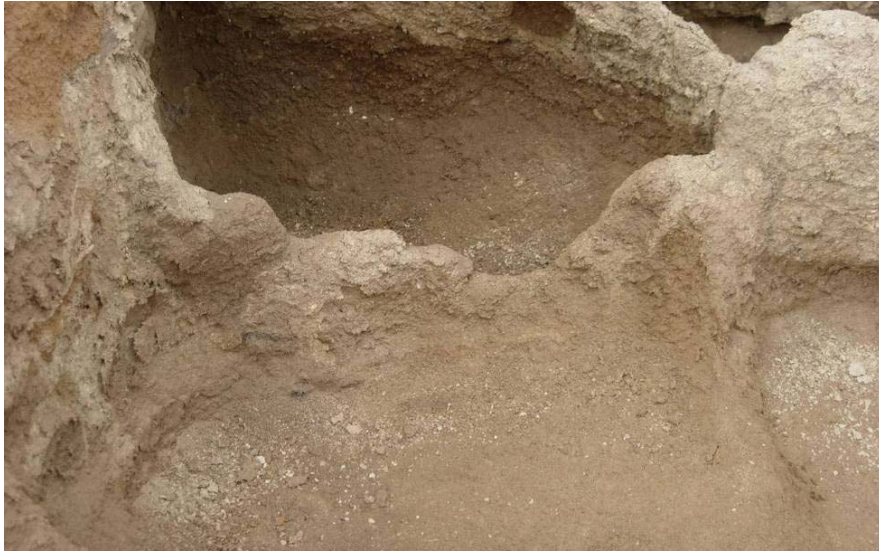
Figure 124: A test area of the bins in Building 5 under the 4040 Shelter. Photo Graeme McArthur

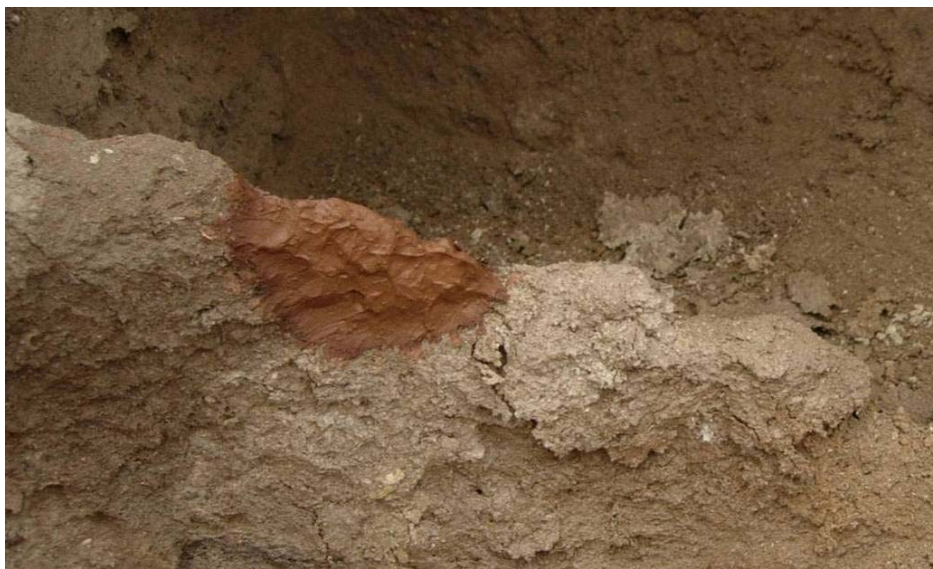
Figure 127: clay mixed with 25% Primal AC-33 applied to the Building 5 bins. Photo Graeme McArthur

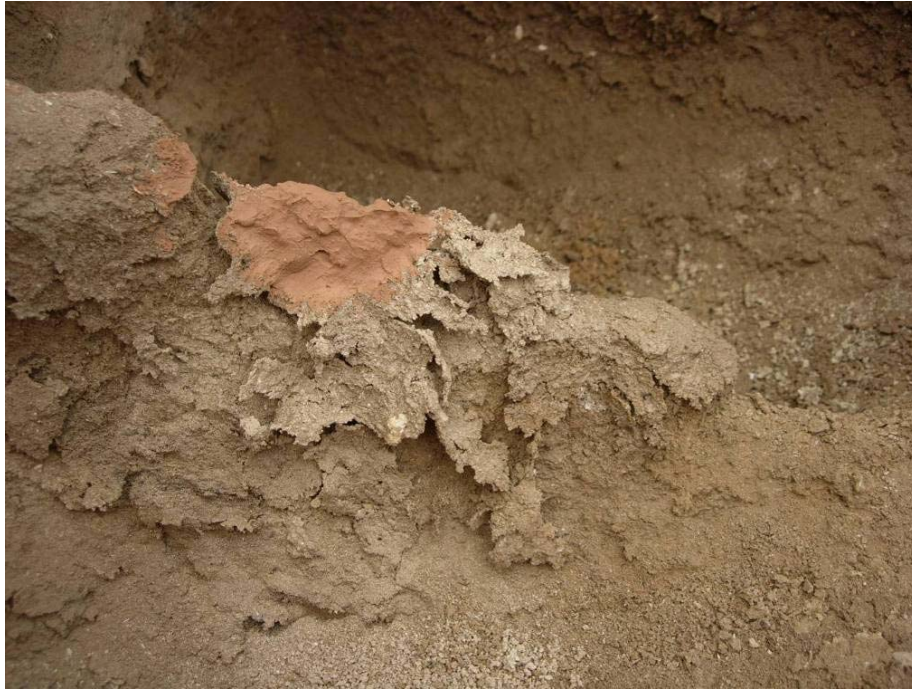
Figure 128: Clay mixed with 25% Primal AC-33 upon drying. Photo Graeme McArthur

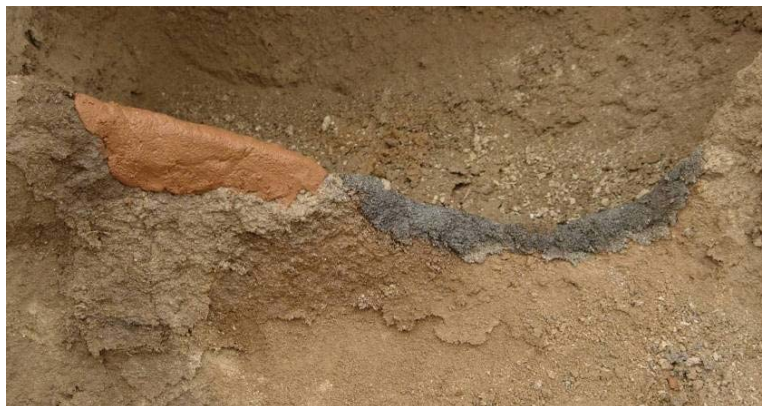
Figure 129: Clay mixed with 50% Primal AC-33 and a mortar applied to a test area of the bins of Building 5. Photo Graeme McArthur

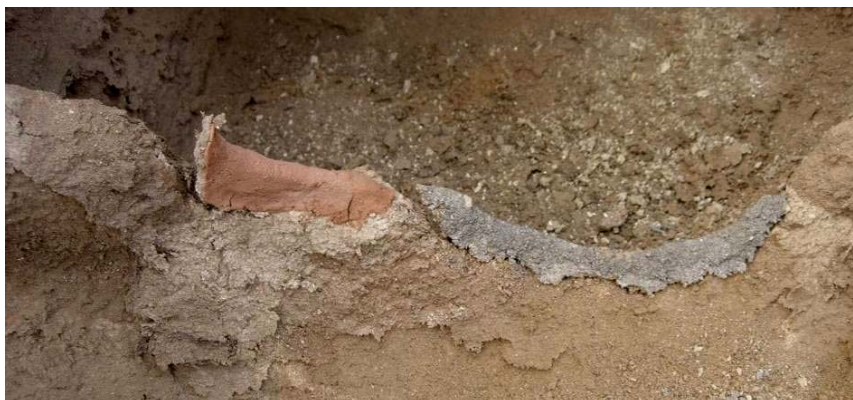
Figure 130: Clay mixture with 50% Primal AC-33 and mortar after drying. Photo Graeme McArthur

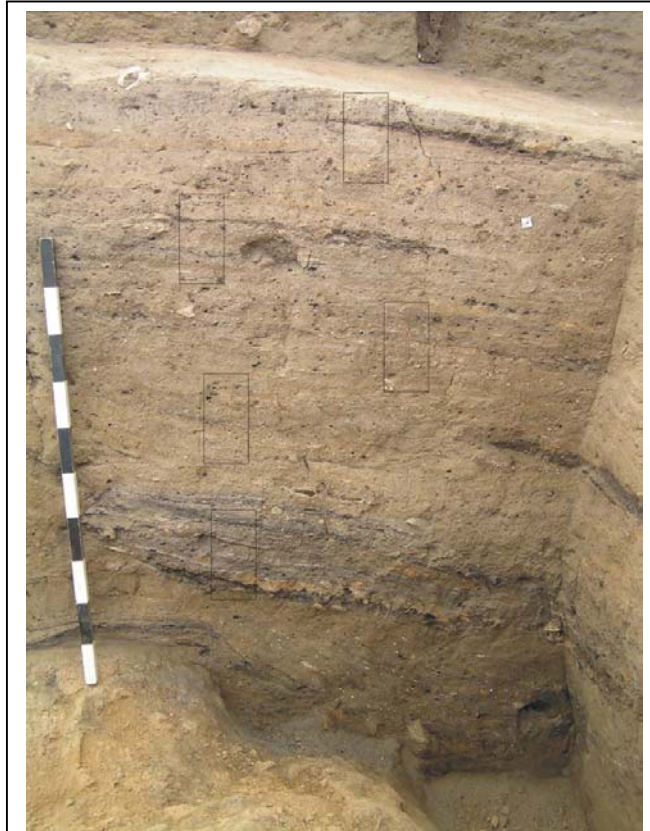
Figure 134: Close up of lower section (Space 130) with thin section block locations marked. Photo Lisa-Marie Shillito

Sequences have so far been analysed from middens in Space 115 and Space 261 in the South Area, Space 279 in the 4040 Area and a midden unit (8932) in TP Area, with 21 thin sections and 300 complementary analyses (FT-IR, GC-MS and phytolith analysis) having been carried out. Aims for the 2009 season included collecting and preparing a final set of samples to complete the sequences analysed as part of PhD research, and targeting the sequence of midden deposits in Space 130 and 339 in the South Area (Figures 133 – 135), where possible surfaces have been identified, and to investigate the

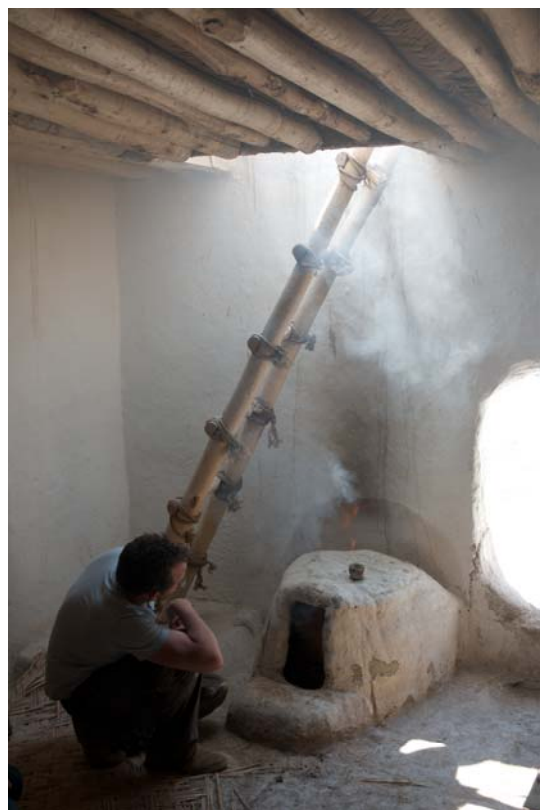
Figure 136: The second burning experiment. Flaming combustion clearly visible from rear vent of oven and smoke seen to be expelled from the compartment.

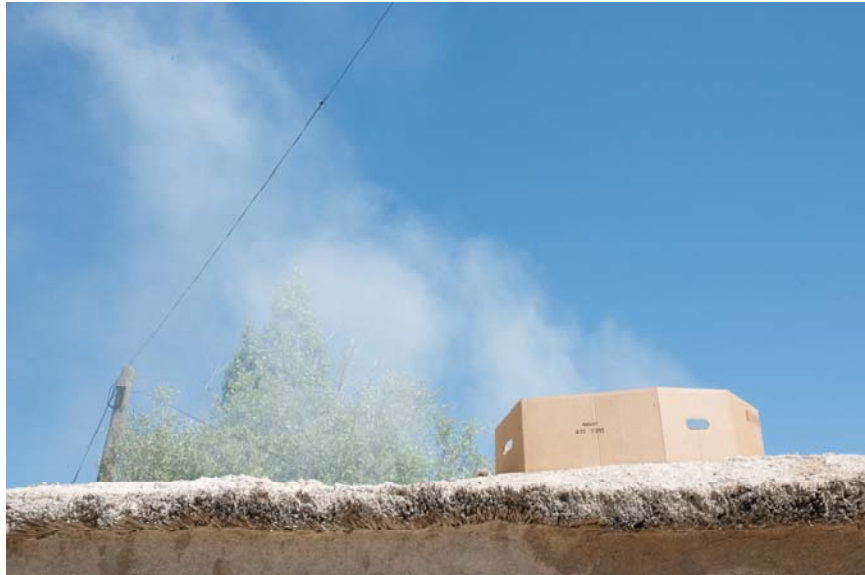
Figure 137: Prototype chimney in place over opening in roof succeeds in assisting the ventilation of the compartment.

As the peak flame of the brushwood died back and the fire began to smoulder, then the lack of thermally-derived convection led to greater lateral spread of the smoke, which no longer favoured the chimney, but rather gathered within the compartment. The observers were forced to leave the building within five minutes of ignition, and the experimenter within six minutes. At this point, the smoke was still not as thick as it had been the previous day. It is theorised that an oven being fuelled over a longer period would build in internal radiant heat flux, resulting in a much more intense smoulder combustion that succeeds in consuming many more of the pyrolysis products that made up the smoke.

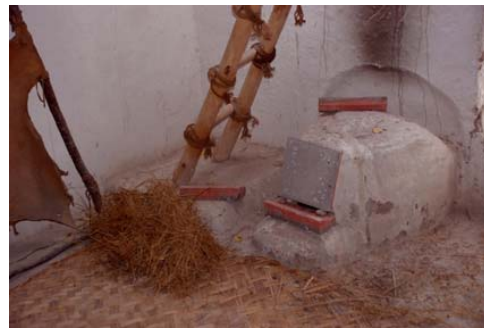
Figure 138: the oven before firing. Photo Daniel Eddisford.

The problem encountered in all earlier attempts to use the reconstructed oven was that of excessive smoke coming from the oven, a consequence of the fire actually being lit within the oven. Even given a tolerance of smoky environments, the quantity of smoke created by previous attempts to light the oven made the house uninhabitable. Therefore, in an attempt to create less smoke within the building the vent on top of the oven and the mouth of the oven were closed off, with only a small air vent left open. A fire was lit outside and hot embers, heated clay balls and heated stones were then brought into the building and placed within the oven (Figure 138 & 139)

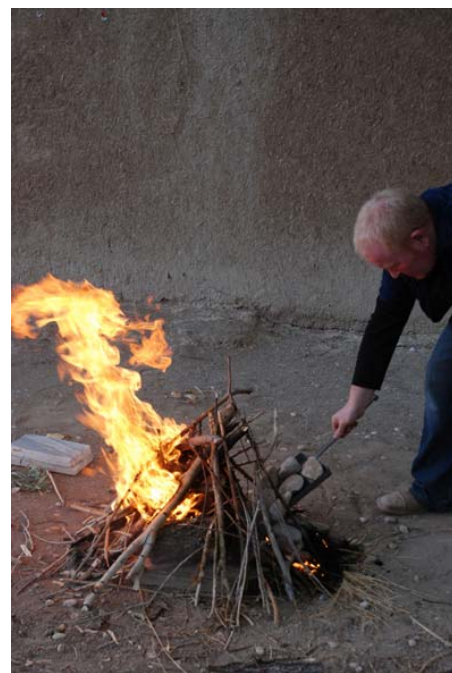
Figure 139: the external fire. Photo Daniel Eddisford.

The fuel used for the fire was wood from local poplar trees and animal dung. These were used in an attempt to replicate the signature of wood and dung charcoal recorded in excavated ovens on the site. Stones and reconstructed clay balls were placed in the fire and heated. Only once the wood and dung began to reduce and become charcoal or white-hot ashes were the fuel, stones and clay balls moved inside to the oven. A metal shovel was used to transport the hot embers; more authentic tools could include large animal scapulas or wetted hides or basketry (Figures 140 & 141).

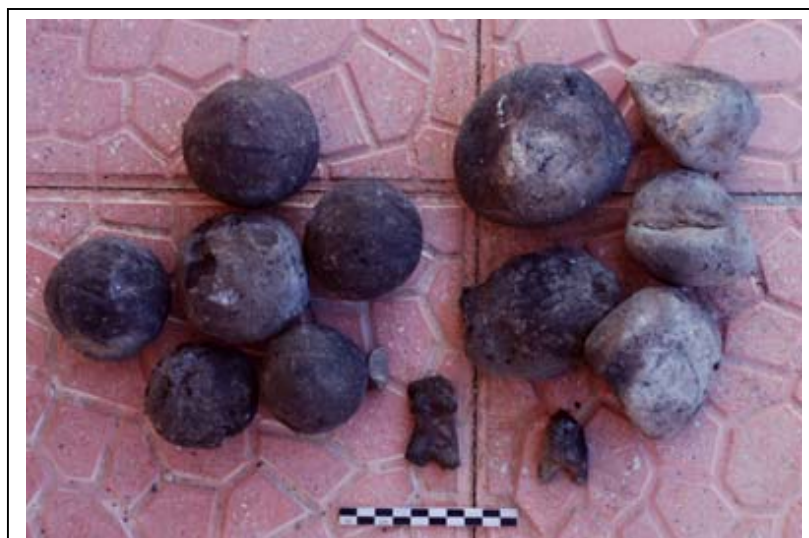
Figure 146: Stones and clay balls after firing. Photo Daniel Eddisford.

The clay balls used in the oven both retained the heat of the fire and provided a good rest for the chicken, keeping it away from direct contact with the hot embers. The stones used in the oven also helped retain the heat. It is interesting to note that after firing the clay balls were clearly heat effected whilst the stones less so. If the function of the stones were not known it is unlikely that it would have been possible to infer from their appearance the fact that they had been used in a fire (Figure 146).
